Florida APT

Tom Byron

Florida Department of Transportation

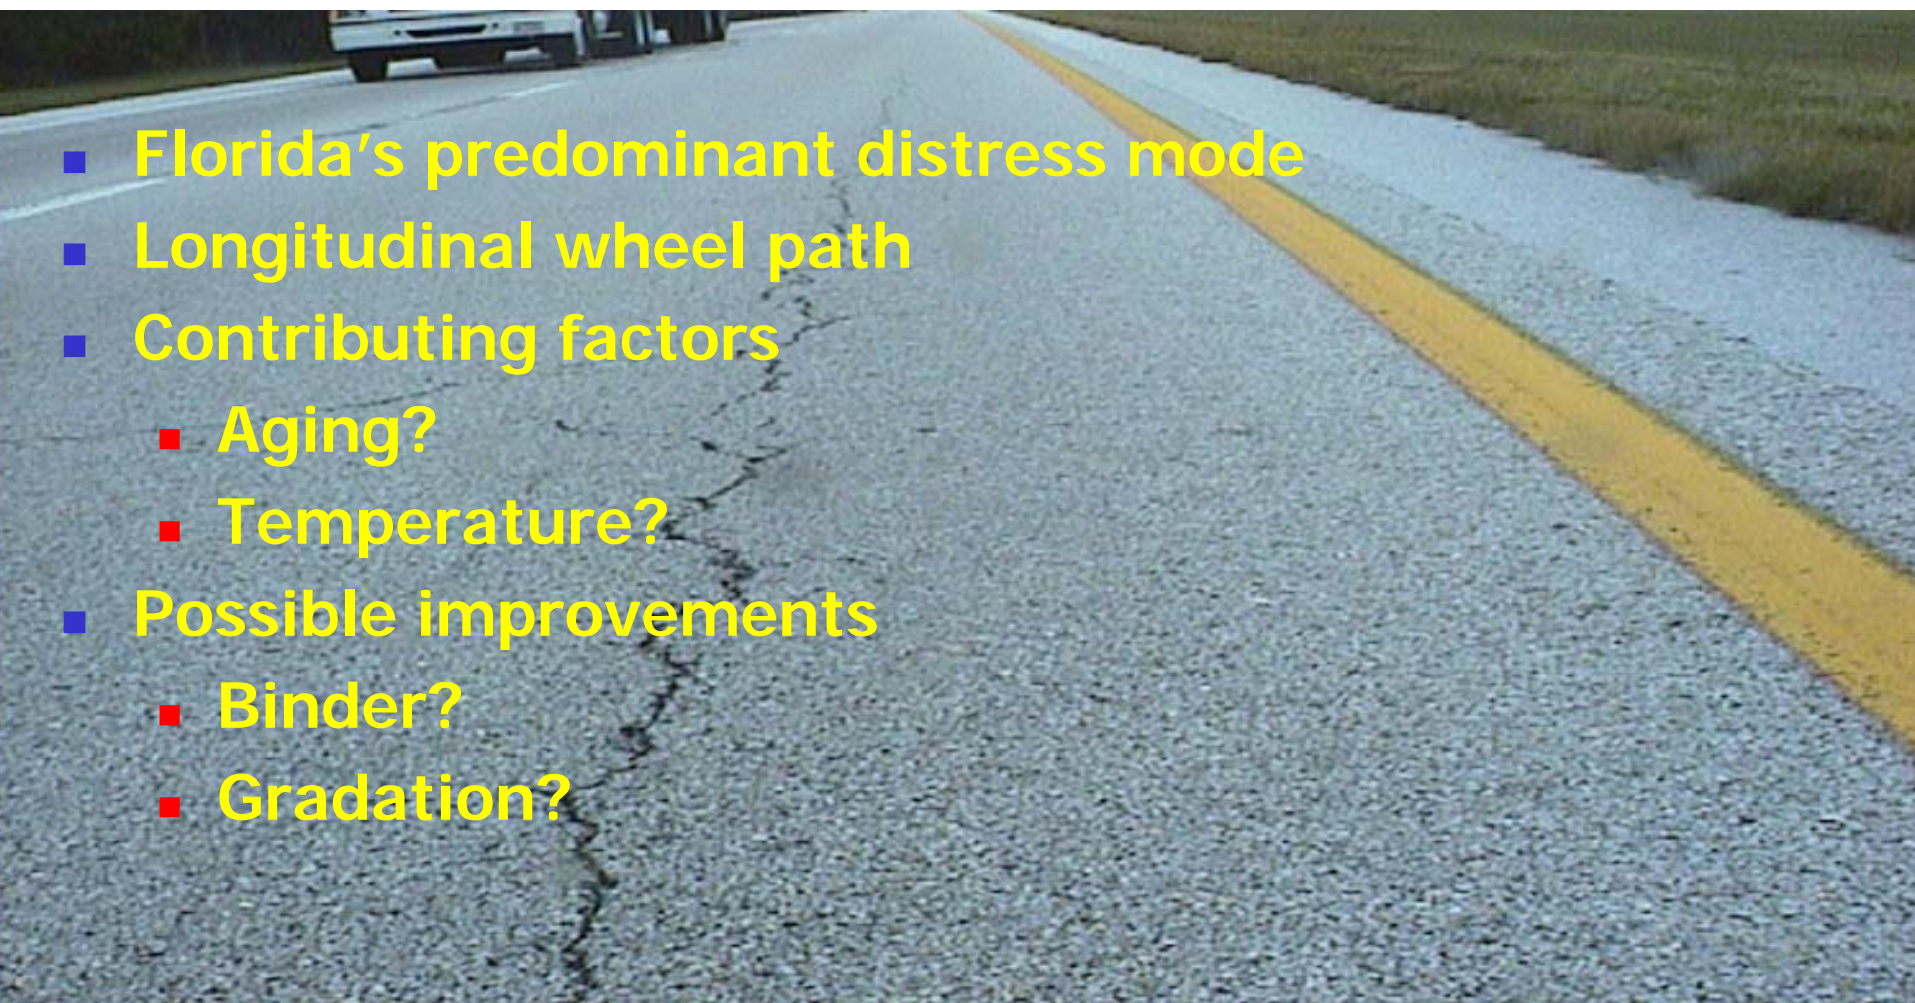
Top Down Cracking

- Florida's predominant distress mode
 - Longitudinal wheel path
 - Contributing factors
 - Aging?
 - Temperature?
 - Possible improvements
 - Binder?
 - Gradation?

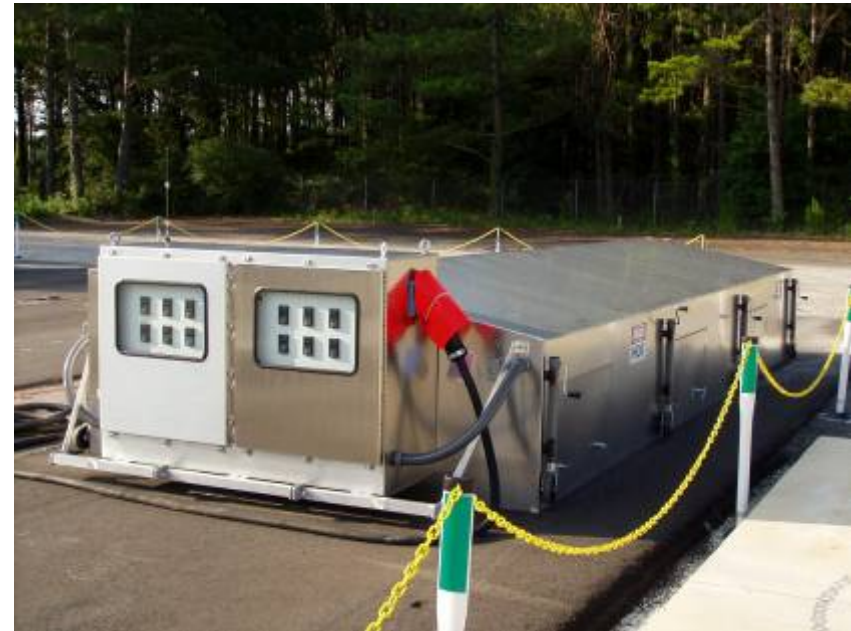
Accelerated Pav't Aging System

- Designed in-house
- Coverage: 10'X24'
- Heats above 90C at 2" depth
- 12 Independent heaters
- 2 x Thermocouples per heater
- Wireless data transmission to HVS Control Room

- The APAS does a great job creating huge viscosity increases and gradients in HMA pavement
- However, aging alone (at least viscosity) is not enough to induce longitudinal wheel path TDC under HVS loading
- Aged pavement strain is less temperature dependent

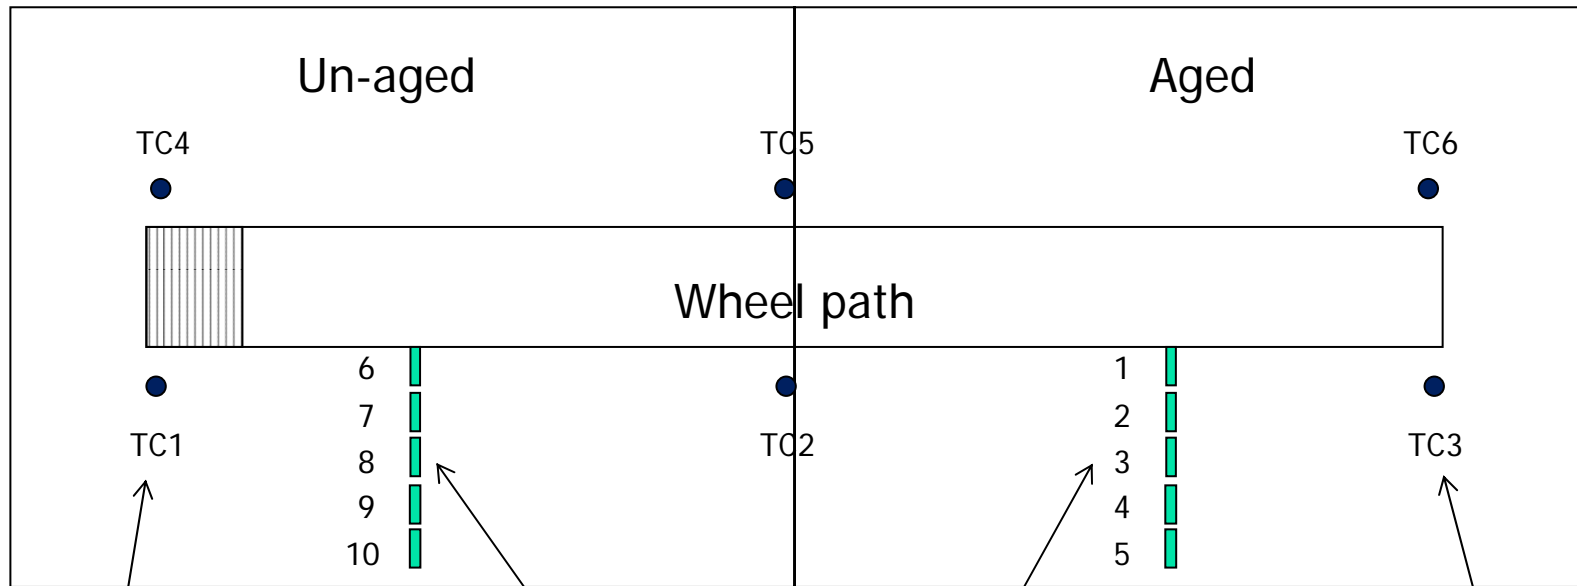
Test Track Layout

Direction of Travel

Thermocouples

Strain Gauges
