Accelerated load testing of pavements

HVS-Nordic tests at VTI Sweden 2003–2004

Leif G Wiman

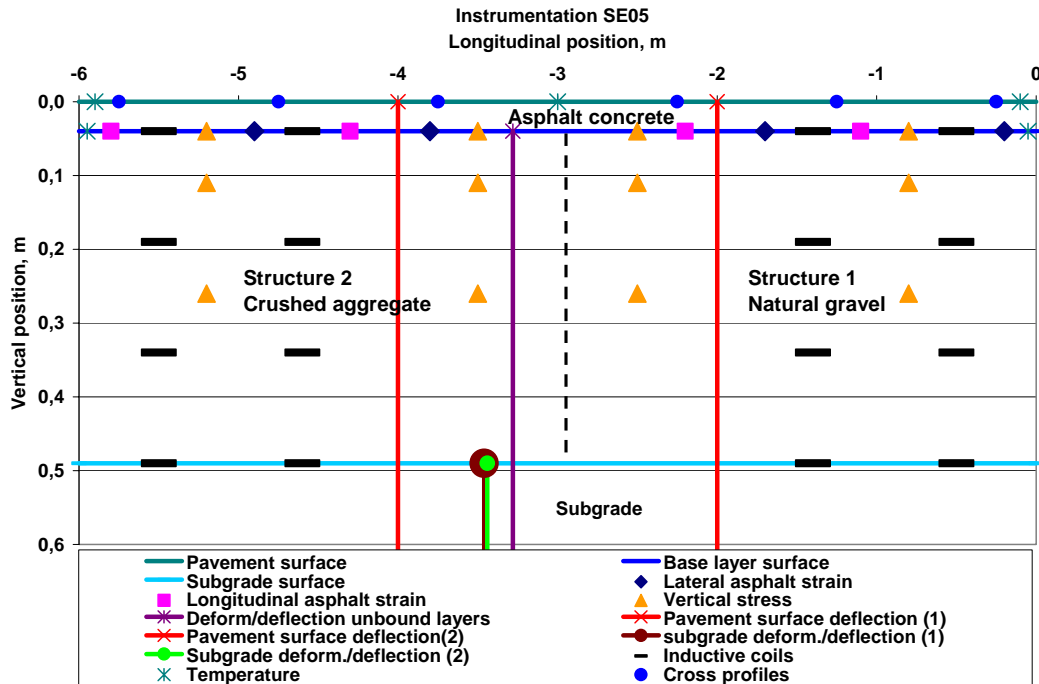
Figure 2 Longitudinal cross section of SE05 instrumentation.

- H-shaped asphalt strain gauges from Dynatest (ASG)
- Soil pressure cells from the University of Nottingham (SPC)
- LVDTs for vertical deflection and deformation
- Inductive coils (ϵ MU) for vertical deformation and strain (static and dynamic)
- Water content reflectometers (WCR)
- Temperature gauges.

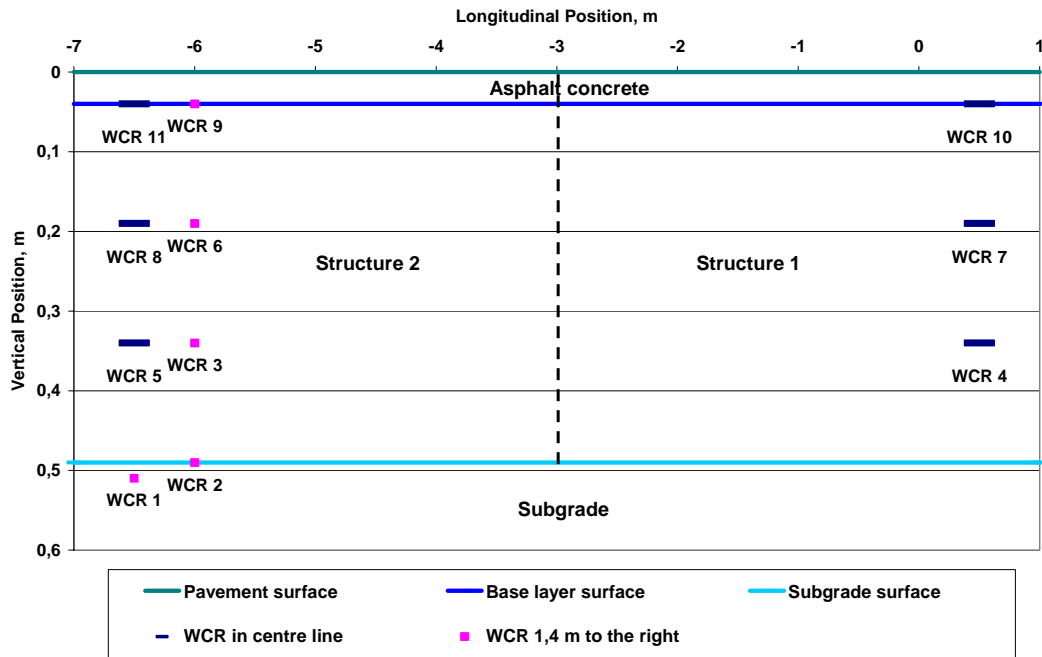
Figure 3 Positions of volumetric water content measurement sensors.

Sensors for measurement of volumetric water content were installed at different depths. The sensors in the centre line were installed outside the test area but in the area where the loading wheel changes direction.

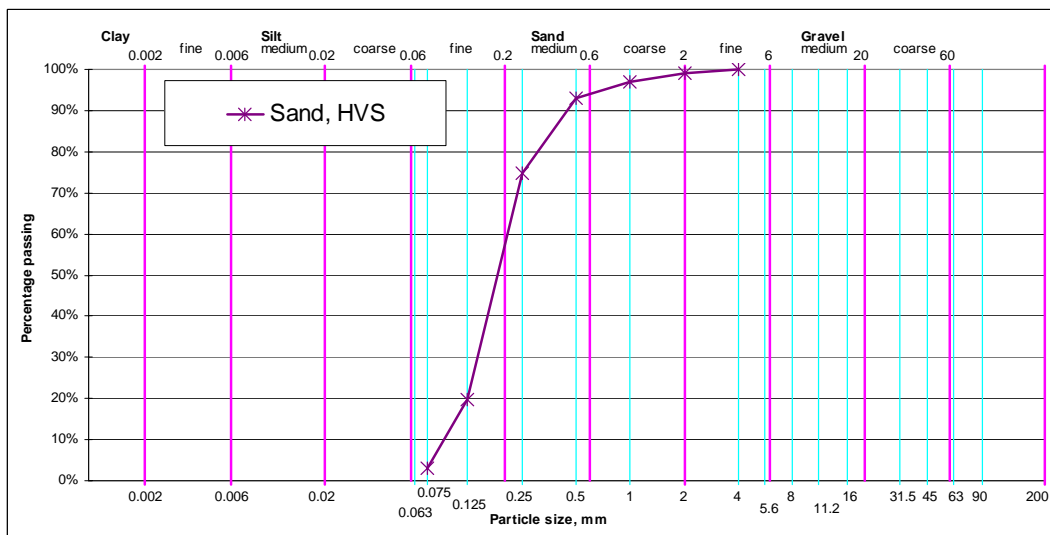
Figure 4 Fine sand subgrade particle size distribution.

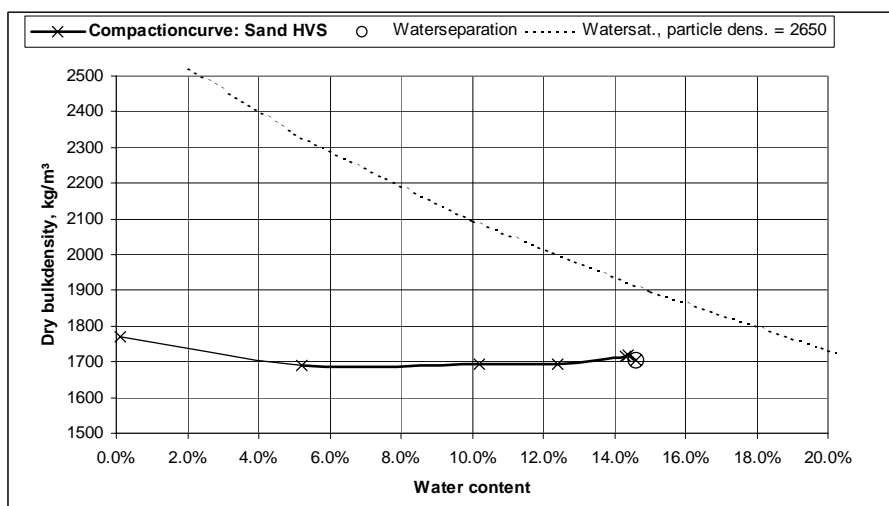
Maximum dry density 1718 kg/m³
 Method: Mod. Proctor VVMB 36:1977
 Optimum water content 14,4 %
 Method: Mod. Proctor VVMB 36:1977

Figure 5 Fine sand subgrade modified Proctor compaction curve.

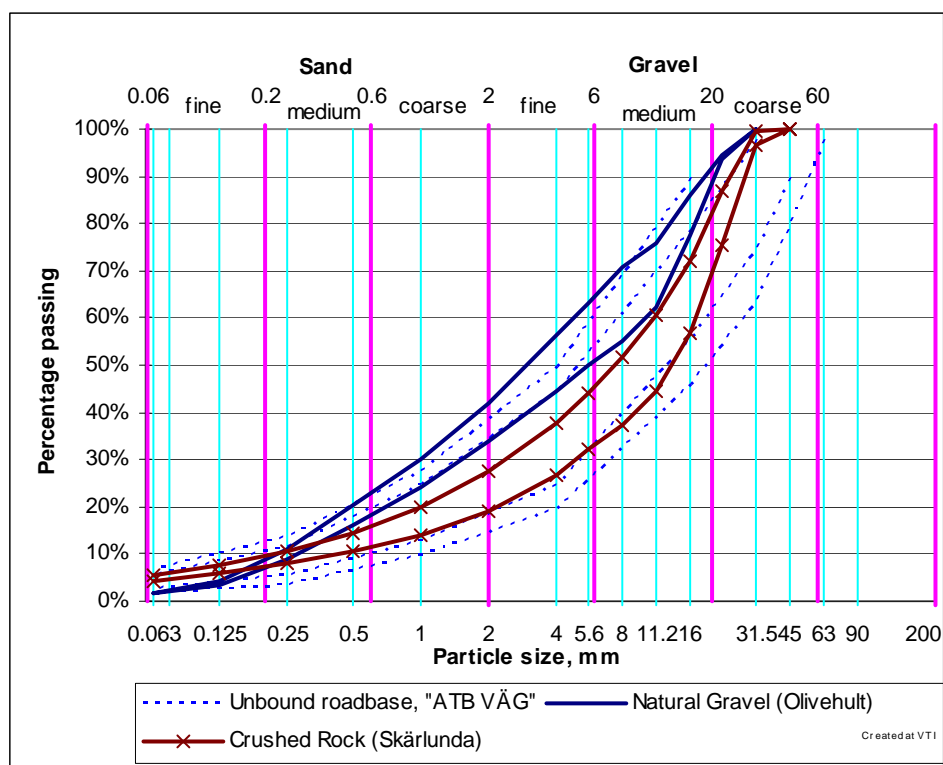
Figure 6 Base layer particle size distribution, maximum and minimum particle size distribution for each base layer material.

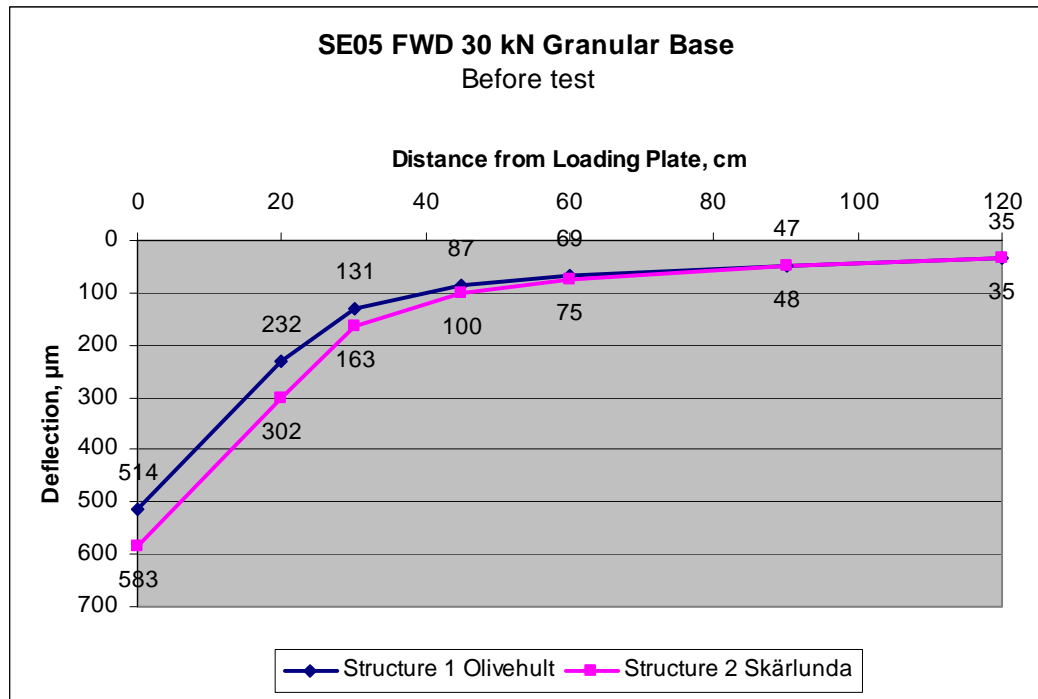
Figure 7 FWD deflections on the surface of the unbound base layers. The deflections shown are mean values from 6 loading positions.

This was done at 6 positions on each structure: three positions 0.5 m to the left and three positions 0.5 m to the right of the HVS loading centre line.

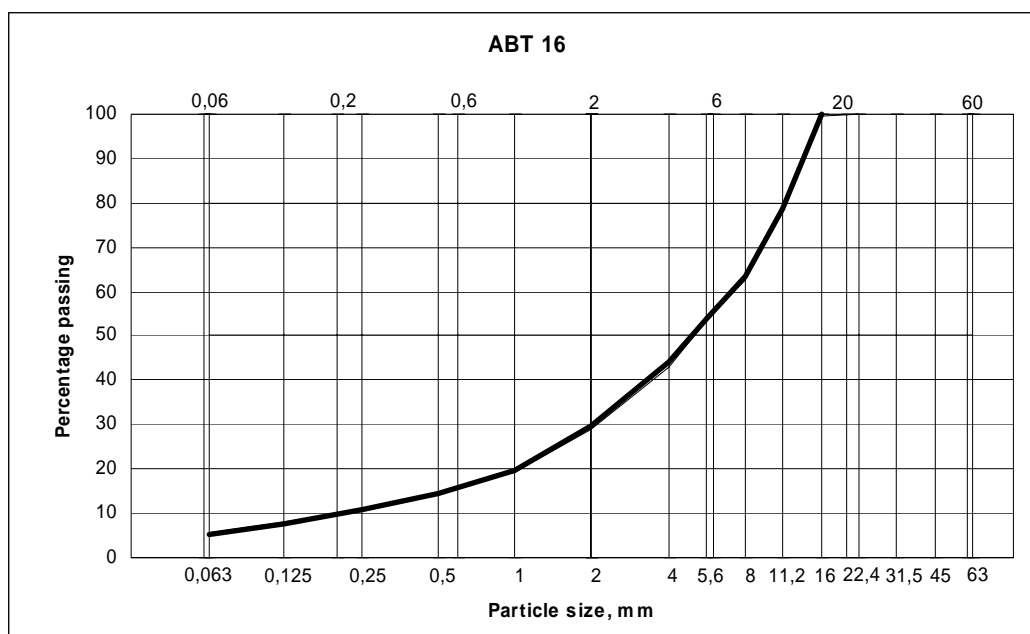
Figure 8 Particle size distribution of dense graded asphalt concrete, ABT16.

The surface layer was dense graded asphalt concrete, ABT16, according to the Swedish specifications.

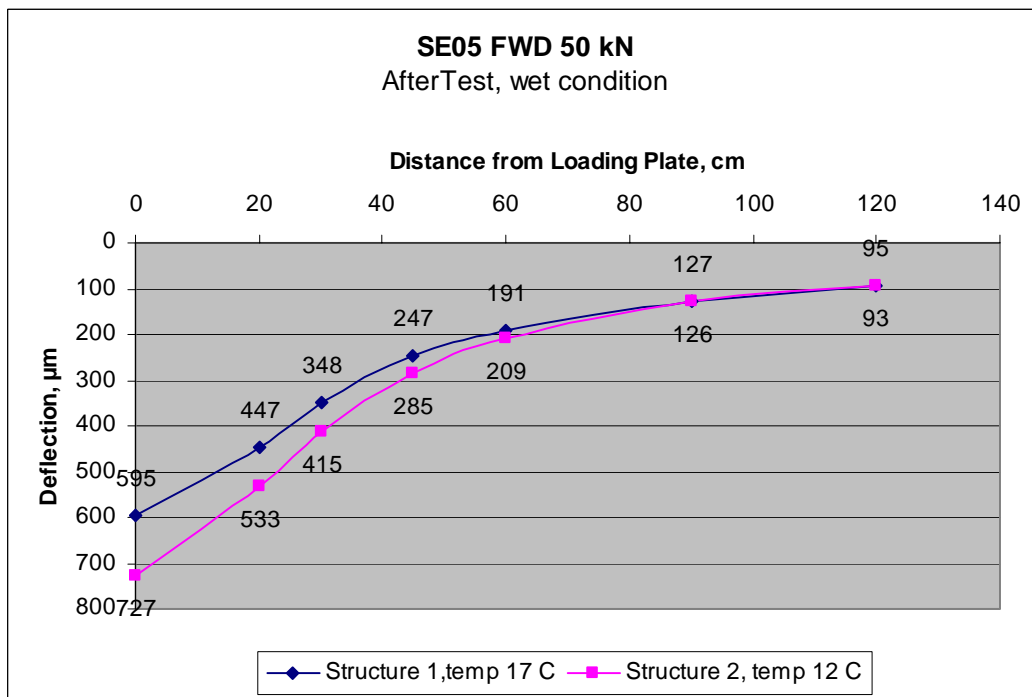
Figure 10 FWD deflections on the pavement surface after test in wet condition, i.e. a ground water table at 30–40 cm below the surface of the subgrade. The deflections shown are mean values from 3 loading positions in the HVS loading centre line.

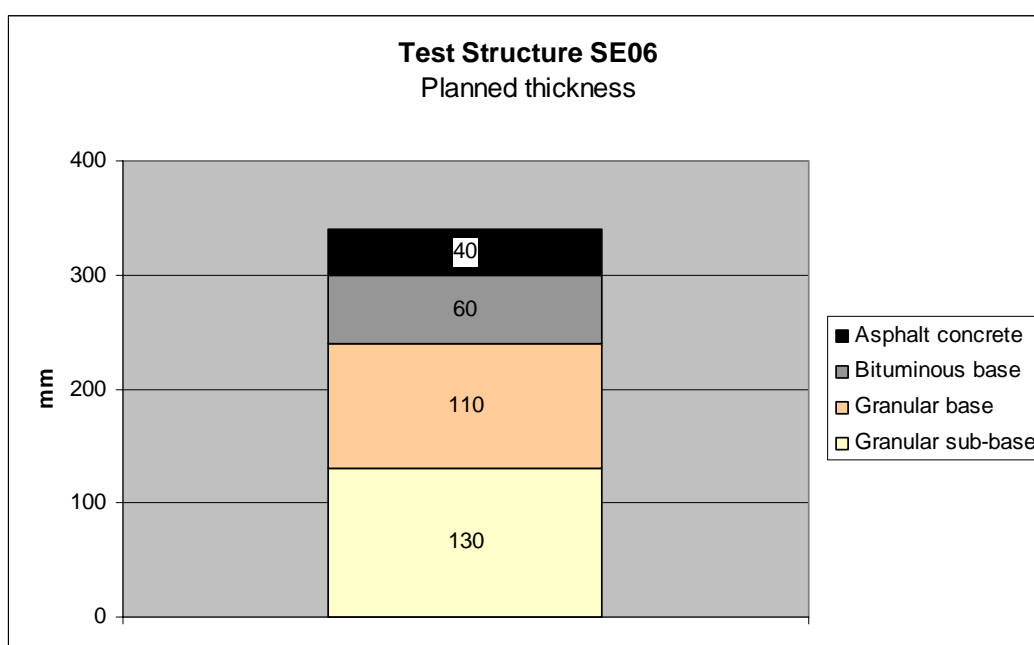
Figure 11 Planned thickness of test structure in SE06.

Layer	Planned thickness	Actual thickness
Asphalt concrete	40 mm	48 mm
Bituminous Base	60 mm	53 mm
Unbound Base	110 mm	108 mm
Unbound Sub-base	130 mm	142 mm
Total thickness	340 mm	351 mm

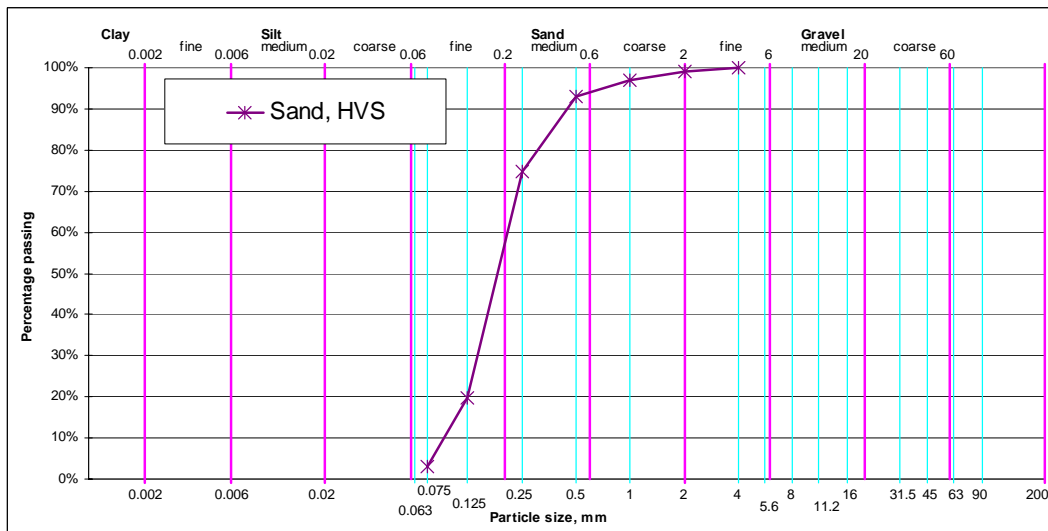
Figure 13 Fine sand subgrade particle size distribution.

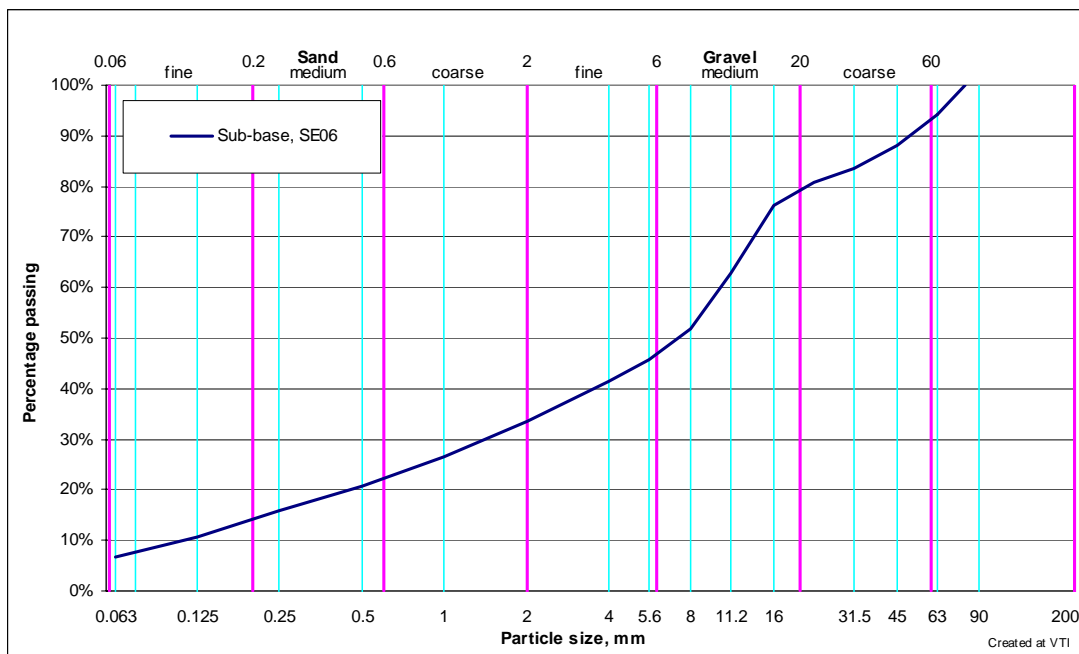
Figure 15 Particle size distribution for the SE06 granular sub-base material.

The material in the sub-base layer was natural gravel and the same as in the previous test, SE02.

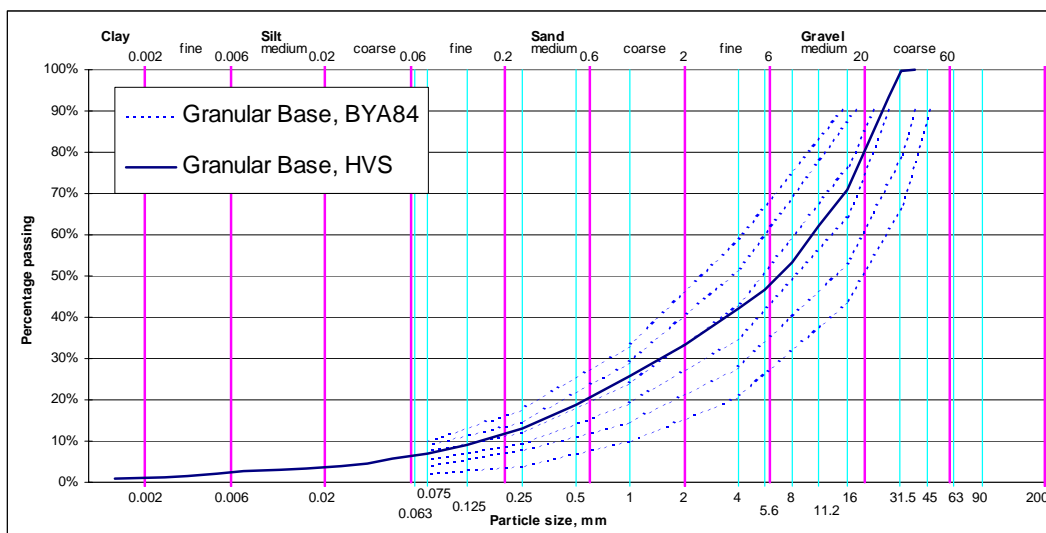
Figure 16 Particle size distribution for the SE06 granular base material.

The base layer material was a natural moraine mixed with crushed material and the same as in the previous tests, SE01 and SE02.

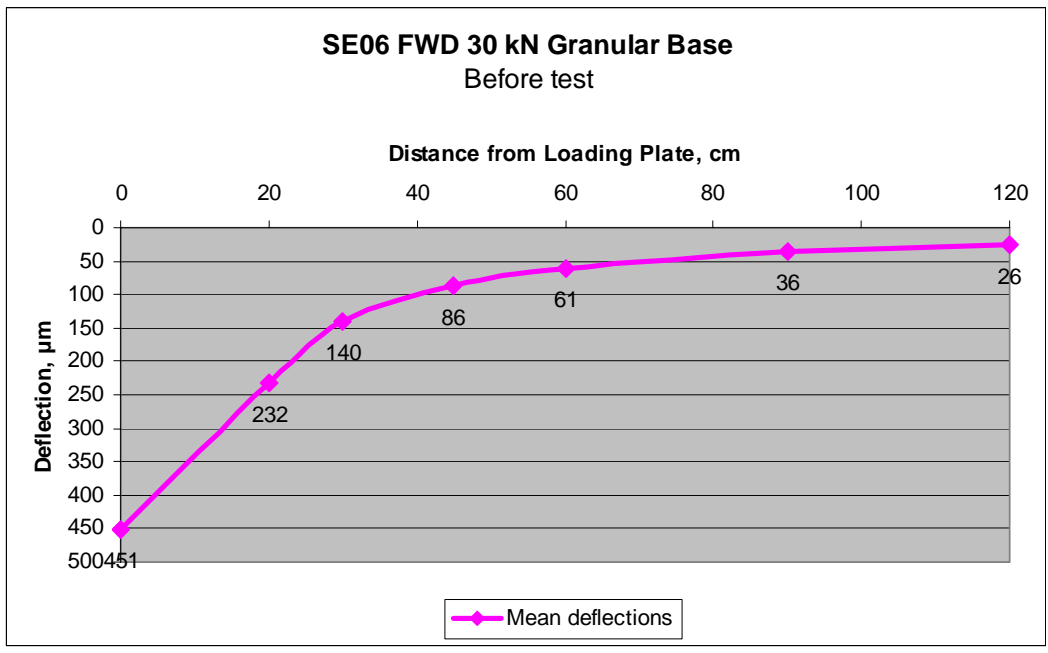
Figure 17 FWD test on surface of granular base layer before test SE06. The deflections shown are mean deflections from seven positions 0.5 m to the right and seven positions 0.5 m to the left of the HVS loading centre line.

Falling weight deflectometer (FWD) measurements was carried out on the surface of the unbound base layer before test SE06 at reduced load (30 kN).

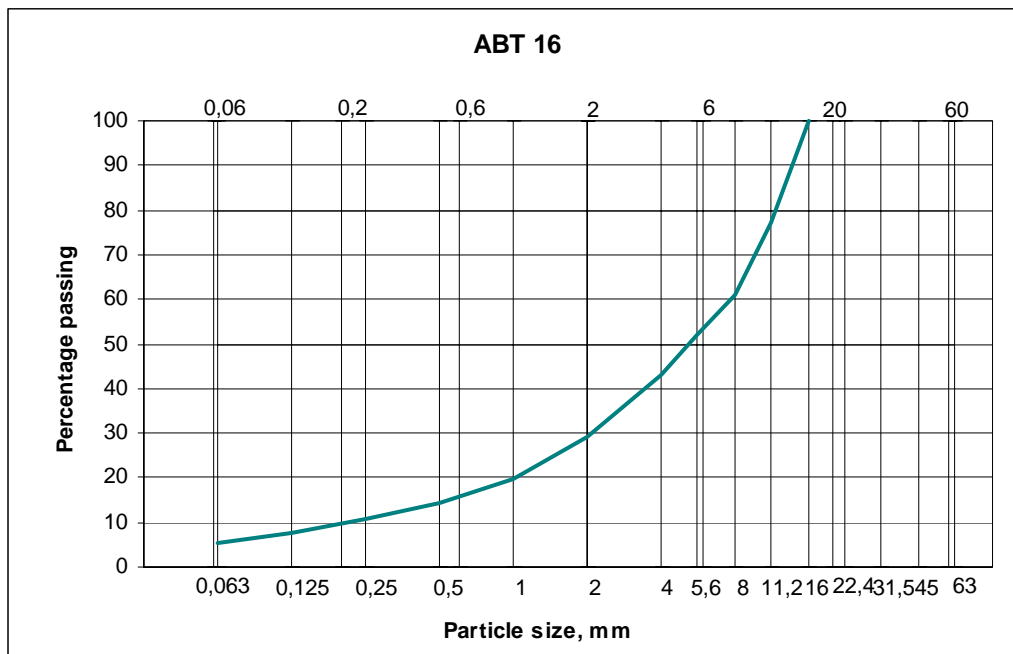
Figure 19 Particle size distribution of dense graded asphalt concrete. ABT16.

The surface layer was dense graded asphalt concrete, ABT16 according to Swedish specifications.

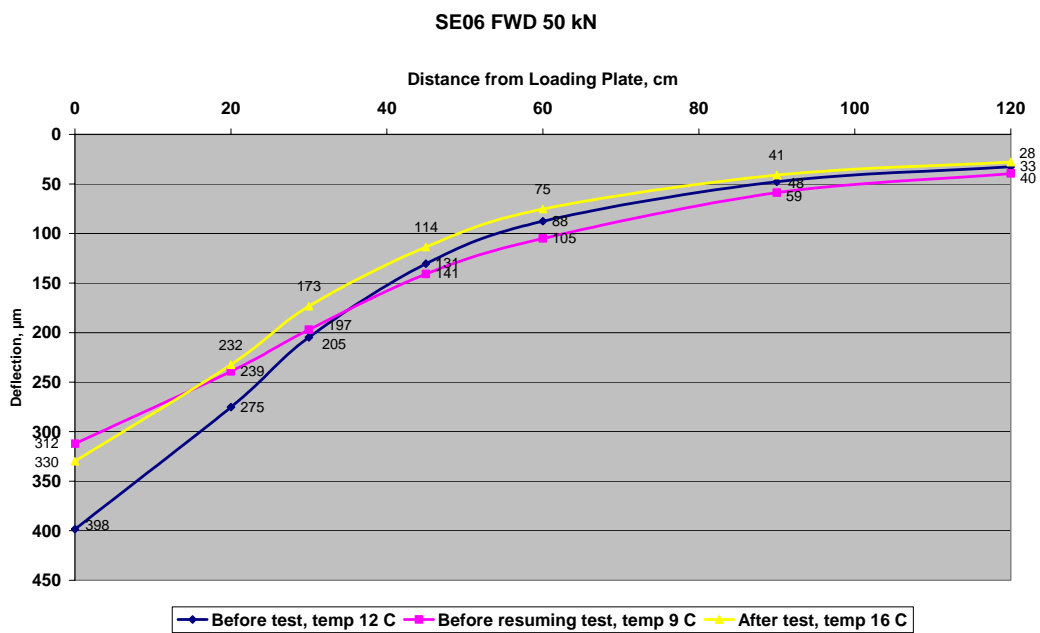
Figure 20 FWD test on pavement surface before test SE06 began, between the test periods, and after the test. The deflections shown are mean deflections from seven positions in the HVS loading centre line.

The SE06 test was interrupted for 10 months due to other tests outside the VTI facility (as mentioned in the introduction).

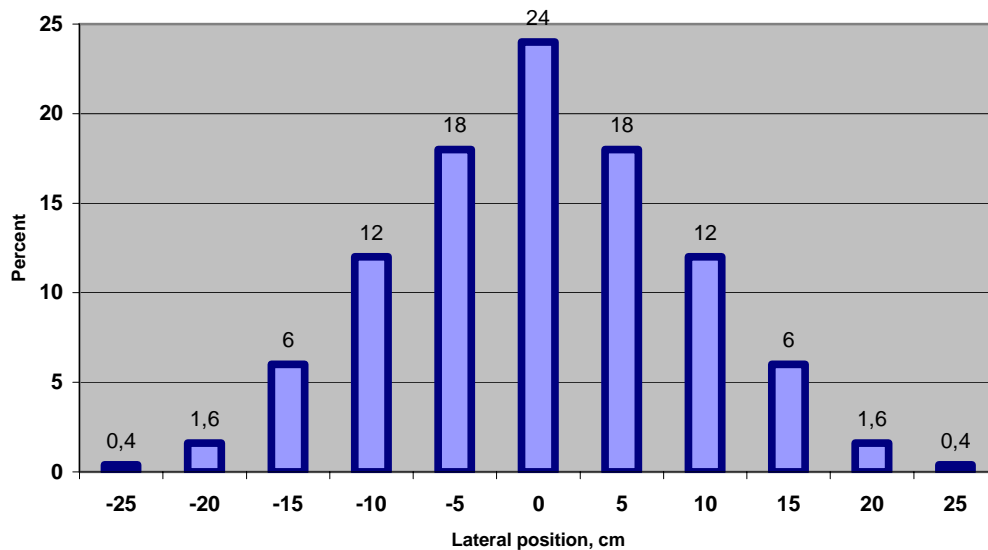
Figure 21 Lateral distribution used in main test with dual wheel load.

- Dual wheel load 60 kN
- Tyre pressure 800 kPa
- Wheel size 295/80R22.5
- Wheel speed 12 km/h
- Bidirectional loading
- Pavement temperature +10 °C
- Lateral distribution.

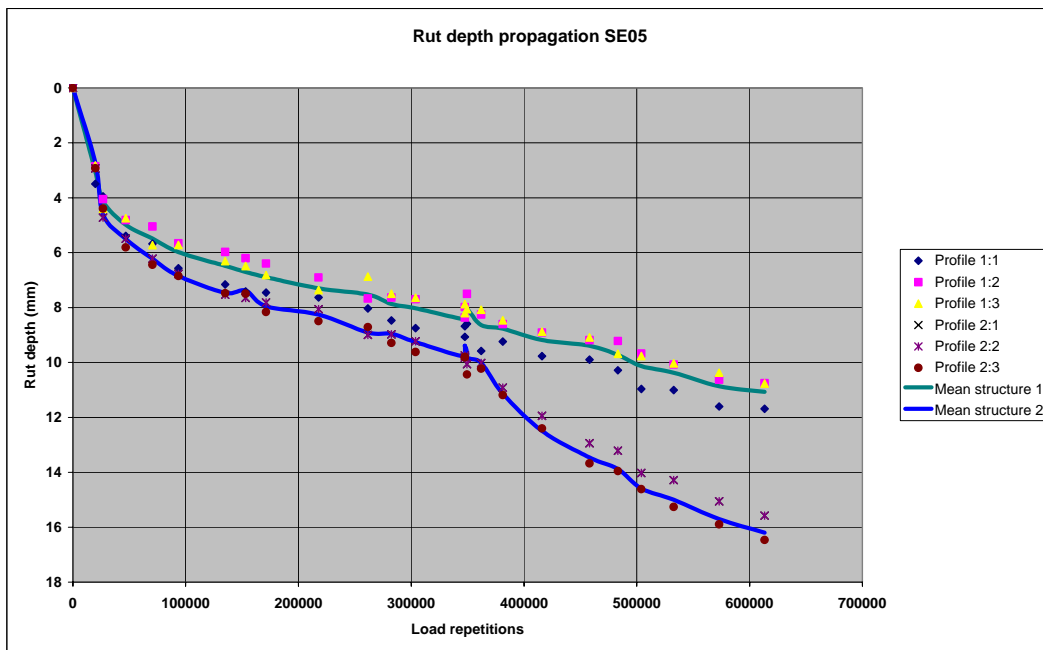
Figure 22 Rut depth propagation in test SE05, structure 1 (Natural granular material) and structure 2 (Crushed rock aggregate).

As mentioned above, the test started in dry condition and after about 350,000 passes, water was added to the subgrade and the structures. The rest of the test was performed in wet condition with ground water level at 30–40 cm below the subgrade surface.

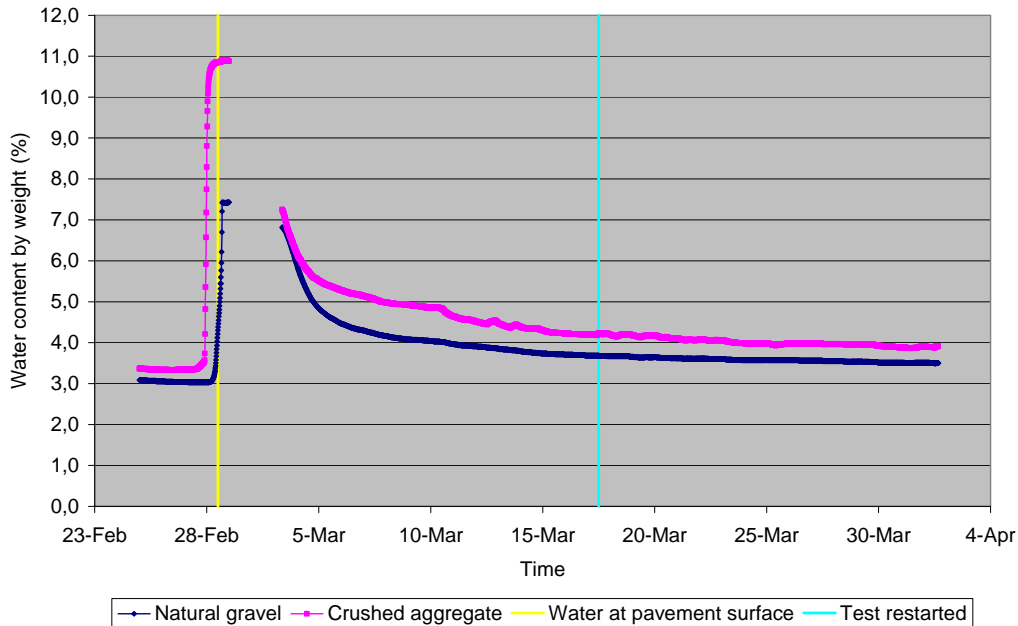
Figure 25 Water content by weight, at a depth of 15 cm from the base layer surface, during raising and lowering of the ground water level.

Figure 25 shows the results from two of these sensors placed at a depth of 15 cm from the base layer surface during the period when ground water level was raised from the bottom of the subgrade to the top of the pavement and then lowered to 30–40 cm below the subgrade surface.

As can be seen, the water content was only raised 0.5% for both materials, from 3.0% to 3.5% for the natural gravel and from 3.4% to 3.9% for the crushed aggregate.

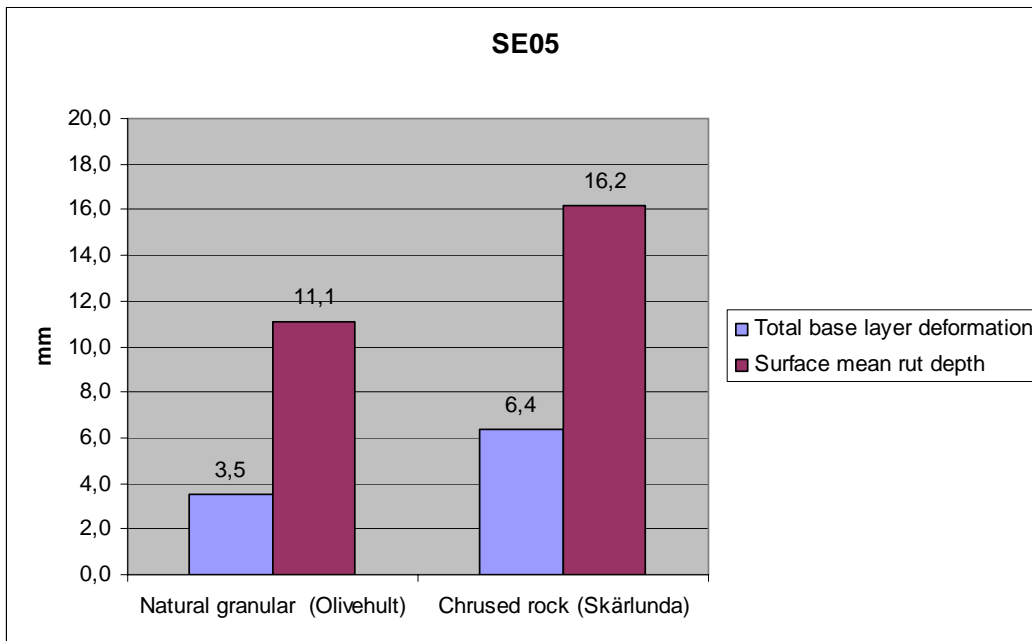
Figure 26 Surface mean rut depth and total base layer deformation at the end of the test (573,000 wheel passes).

The nominal thickness of the unbound base layers was 450 mm. The change in thickness due to the loading was measured using inductive coils (εMU-coils). The measurement was subdivided into three thirds of the thickness, 0–150 mm, 150–300 mm, and 300–450 mm. The measurements of the change of these thickness at the end of the test (573,000 wheel passes) are compared with the surface rut depth measured at the same time.

More than half of the difference in rut depth on the surface can be found in the difference in the base layer deformation, and most of the deformation of the base layers are related to the upper part (0–150 mm) of these layers.

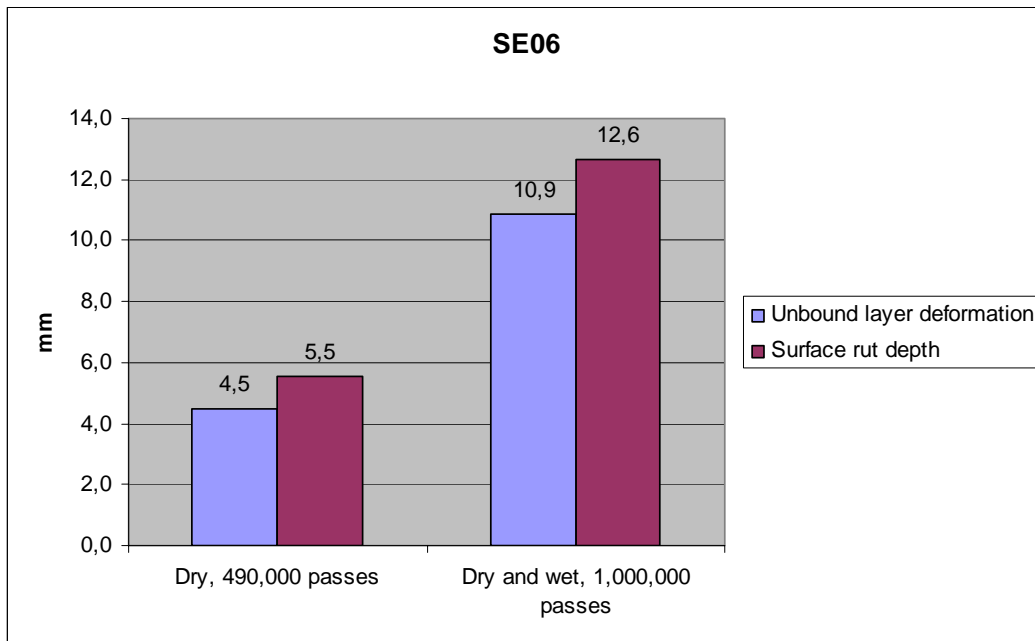
Figure 30 Total deformation of unbound layers compared to pavement surface rut depth. Unbound layers include base, sub-base, and the upper 300 mm of the subgrade.

As in the previous test, the changes in thickness of the unbound pavement layers were measured by inductive coils (EMU-coils). The base layer, the sub-base layer, and the upper part of the subgrade (divided into two layers) were measured separately. The accumulated results from these measurements after the first period in dry condition, and after completion of the test, both dry and wet conditions, are shown below.

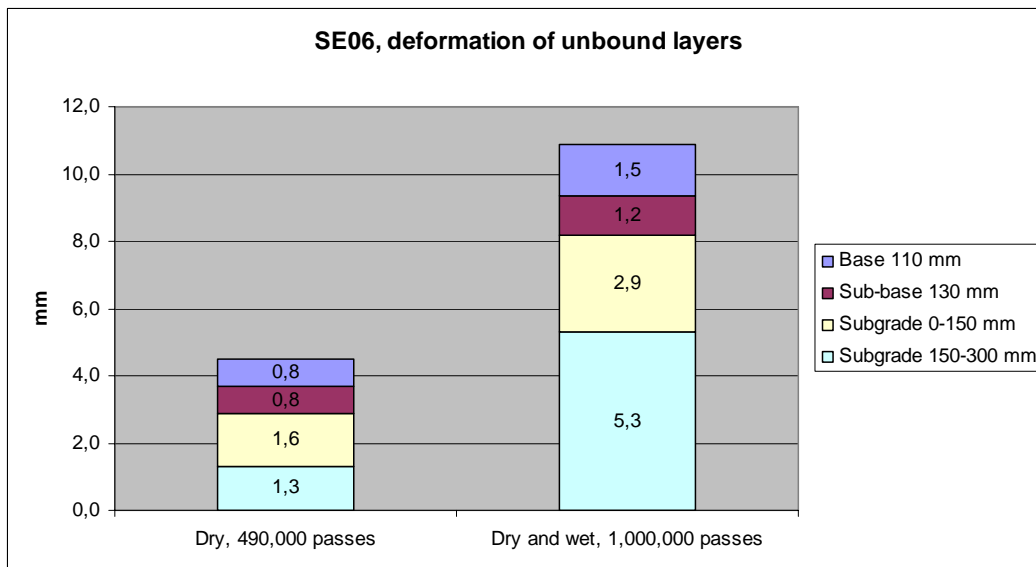
Figure 31 Total deformation of unbound pavement layer divided into the deformations of the individual layer.

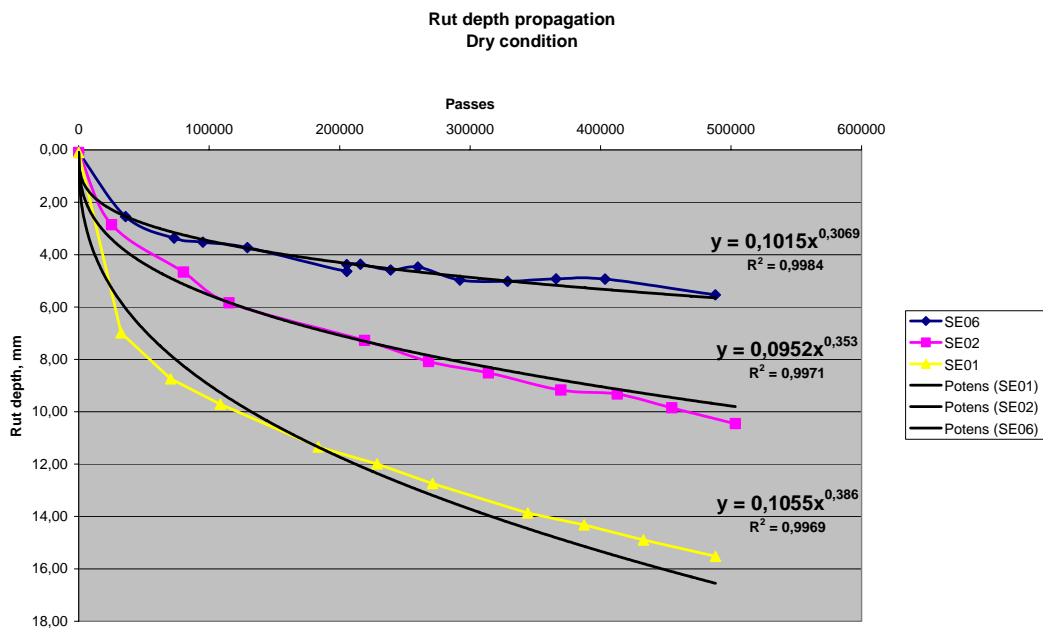
Figure 33 Rut depth propagation in dry condition and regression lines for the pavement test structures with increasing bearing capacity.

The rut depth propagation during the first phase, in dry condition, for these three tests showed a good fit with exponential regression lines.

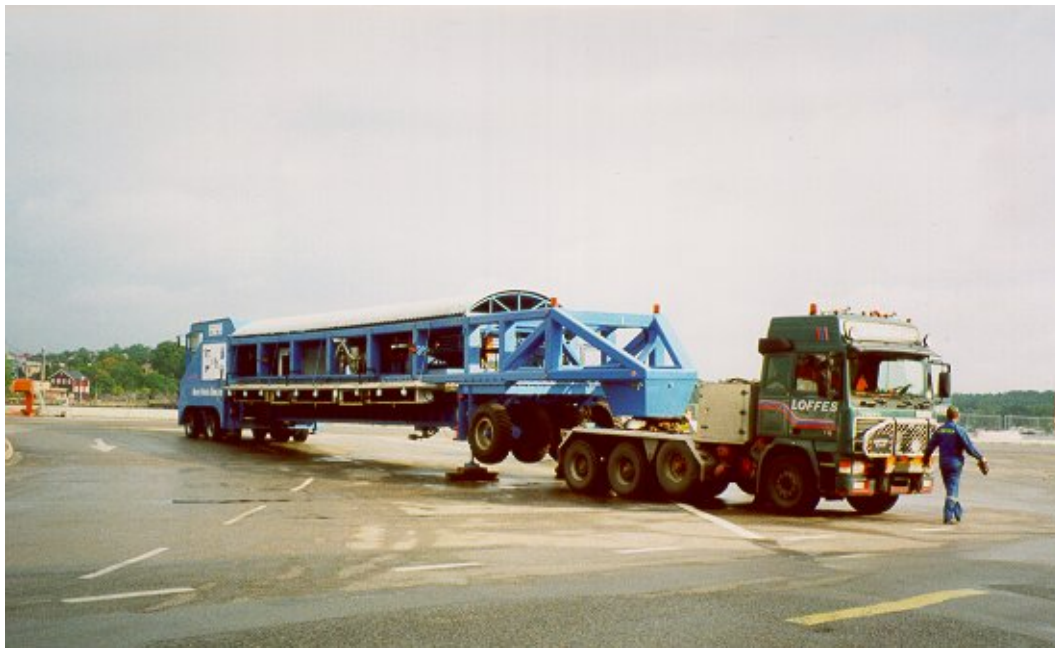
Figure 1 Transportation of HVS-NORDIC.

The HVS-NORDIC is a mobile linear full-scale accelerated pavement-testing machine (HVS Mark IV), figure 1. The machine can be run over a short distance by itself at walking speed and can be moved as a semi-trailer over longer distances. Its speed during transportation by road is about 50 km/h but special permits are needed. Because it has steering wheels, it can, in spite of its length, negotiate even relatively sharp corners.

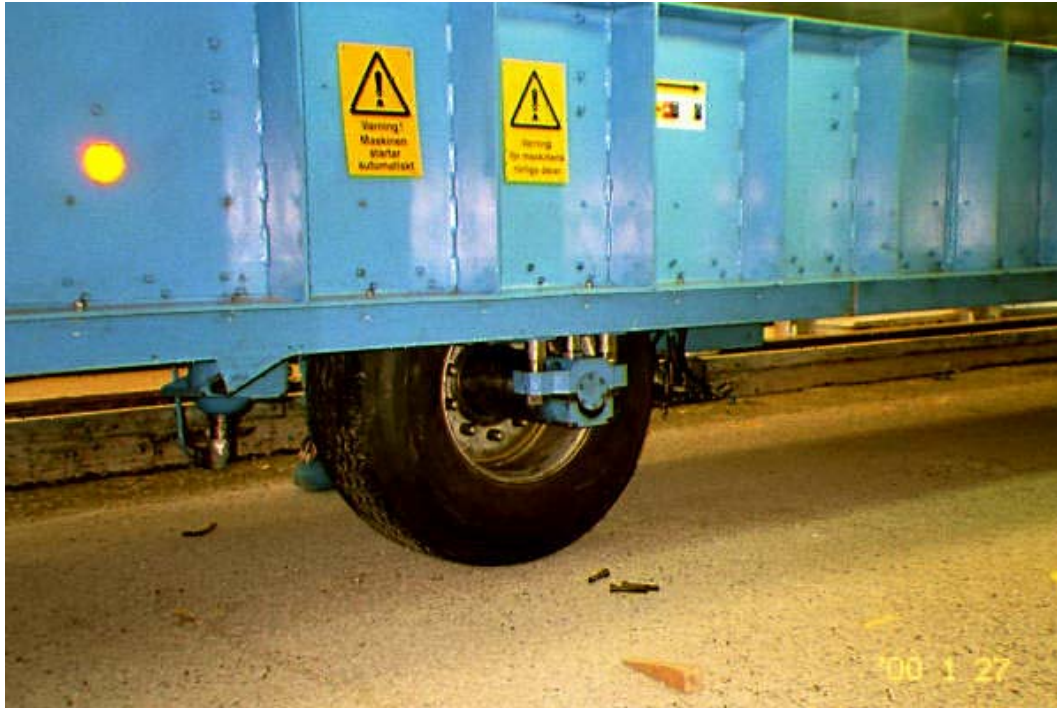
Figure 2 HVS-NORDIC loading wheel.

The HVS is 23 m long, 3.5 m wide, 4.2 m high, and weighs 46 tonnes. The wheel load can be varied from 30 kN to 110 kN (corresponding axle loads 60...220 kN) at speeds up to 12 km/h. The machine can be run 24 hours a day, even during the night with no staff present.

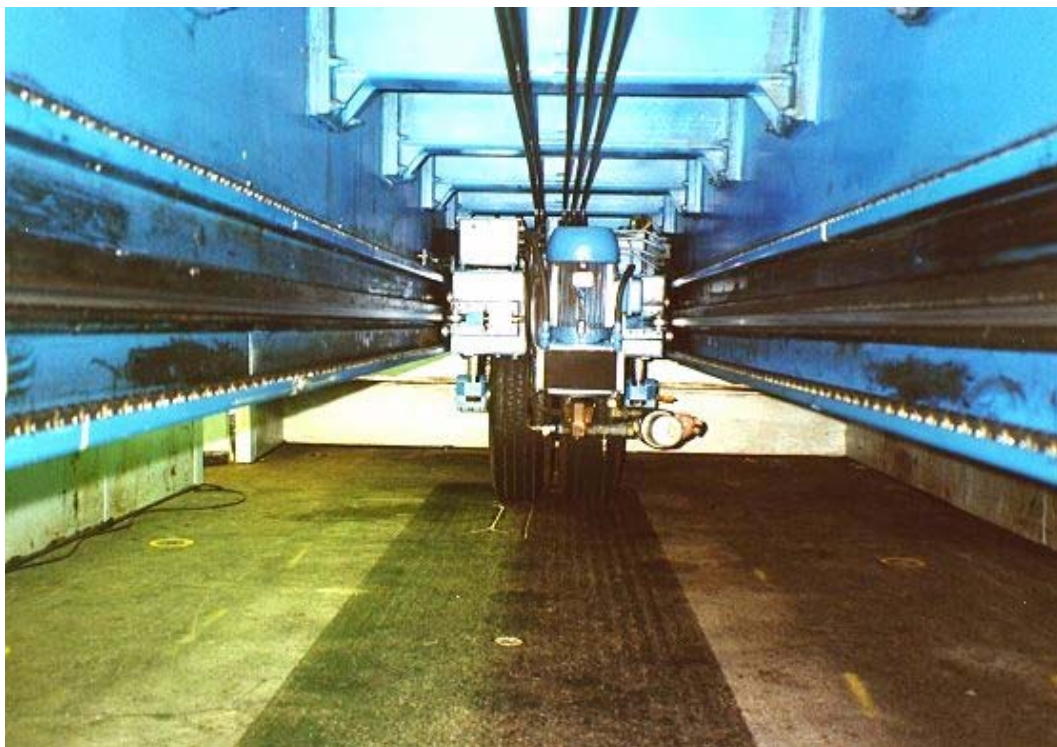
Figure 3 Inside view of test-carriage and loading wheel.

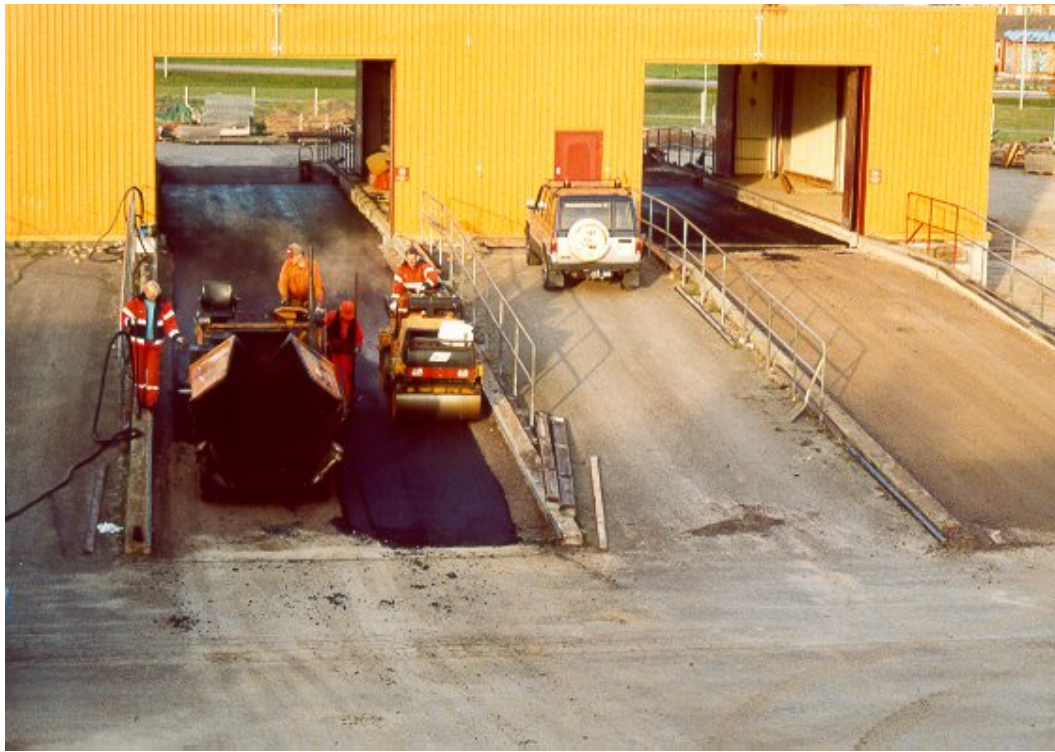
Figure 4 Full-scale pavement test facility at VTI, Linköping.

5 m wide, and 15 m long. Using two test pits means that one test section can be constructed while the test is running on the other. See figure 5.

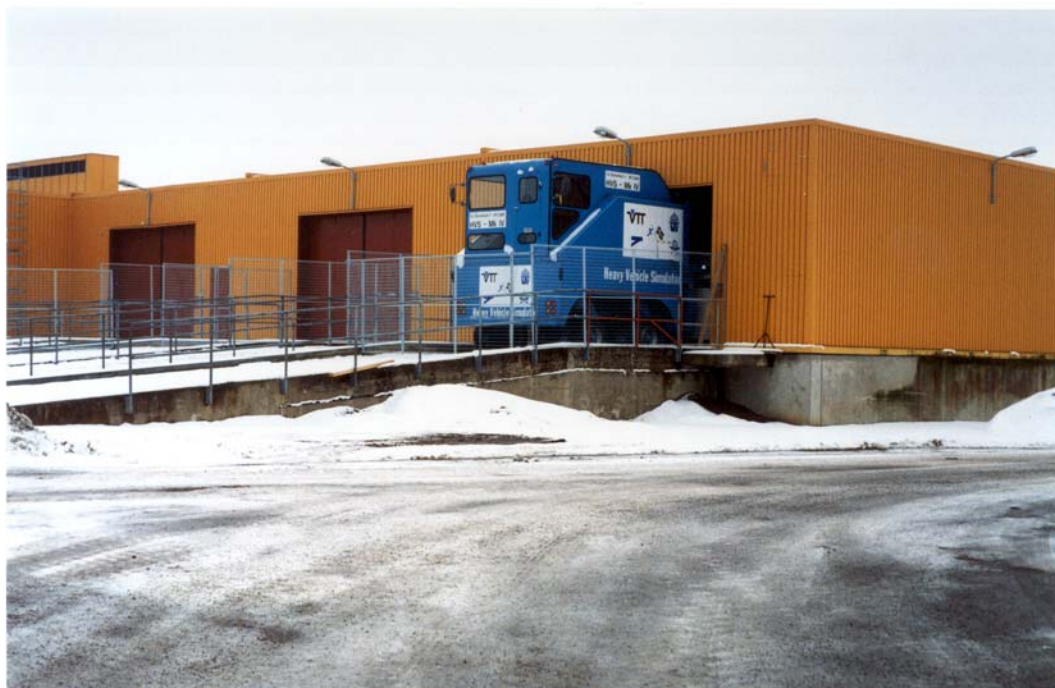
Figure 5 HVS machine during test.
