# Improving the Mechanistic Design Method

# Improving the DESIGN Method

## Mechanistic Principles

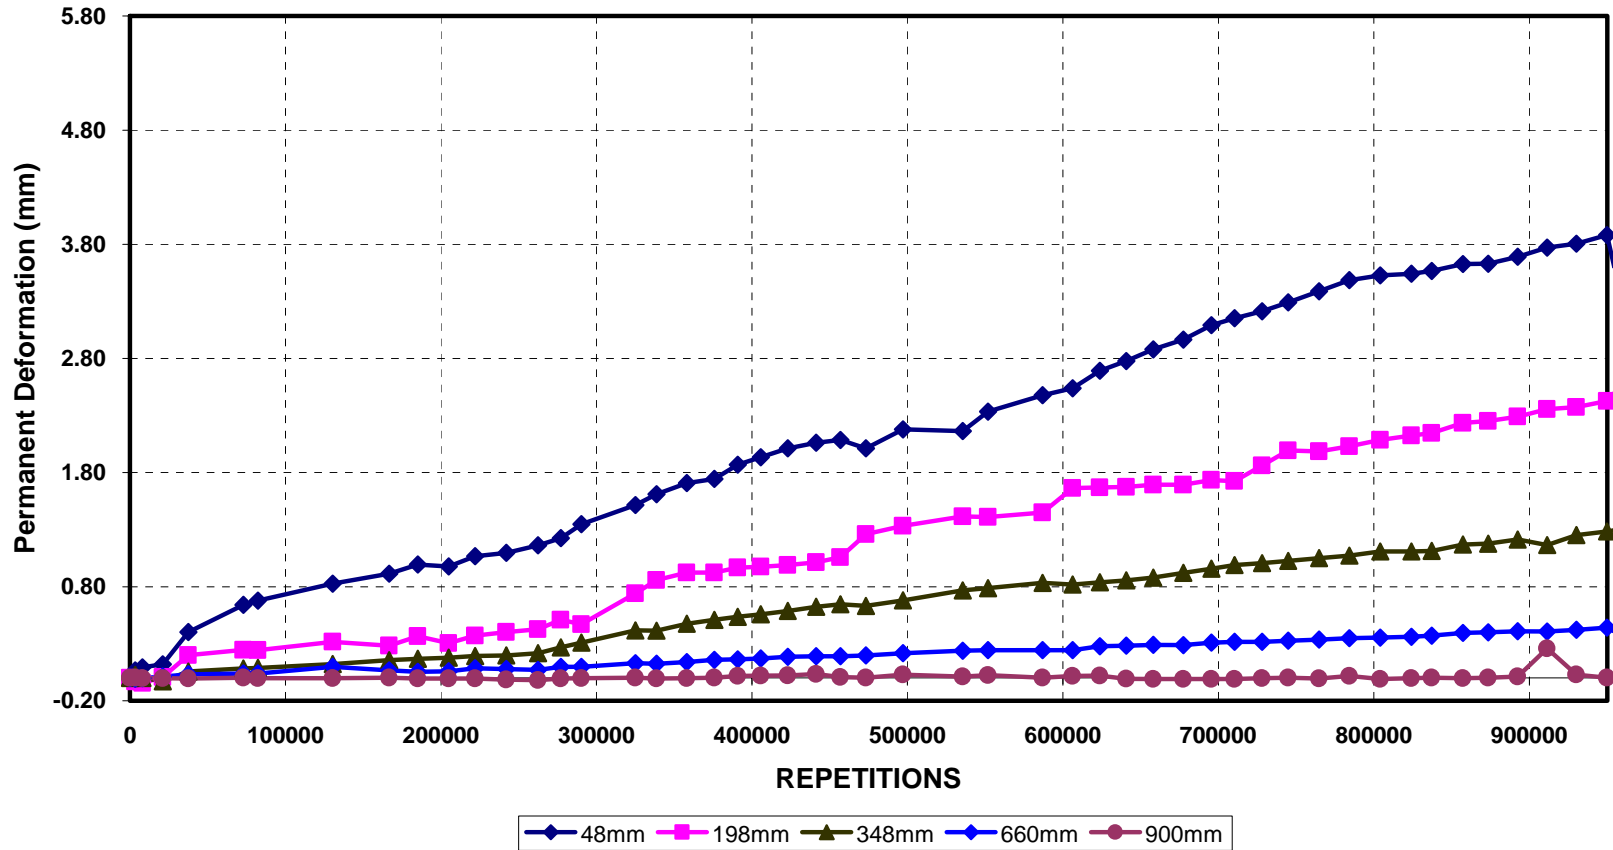
# N12: Rutting vs. HVS Reps

MDD 4 Permanent Deformation SECTION 425A5

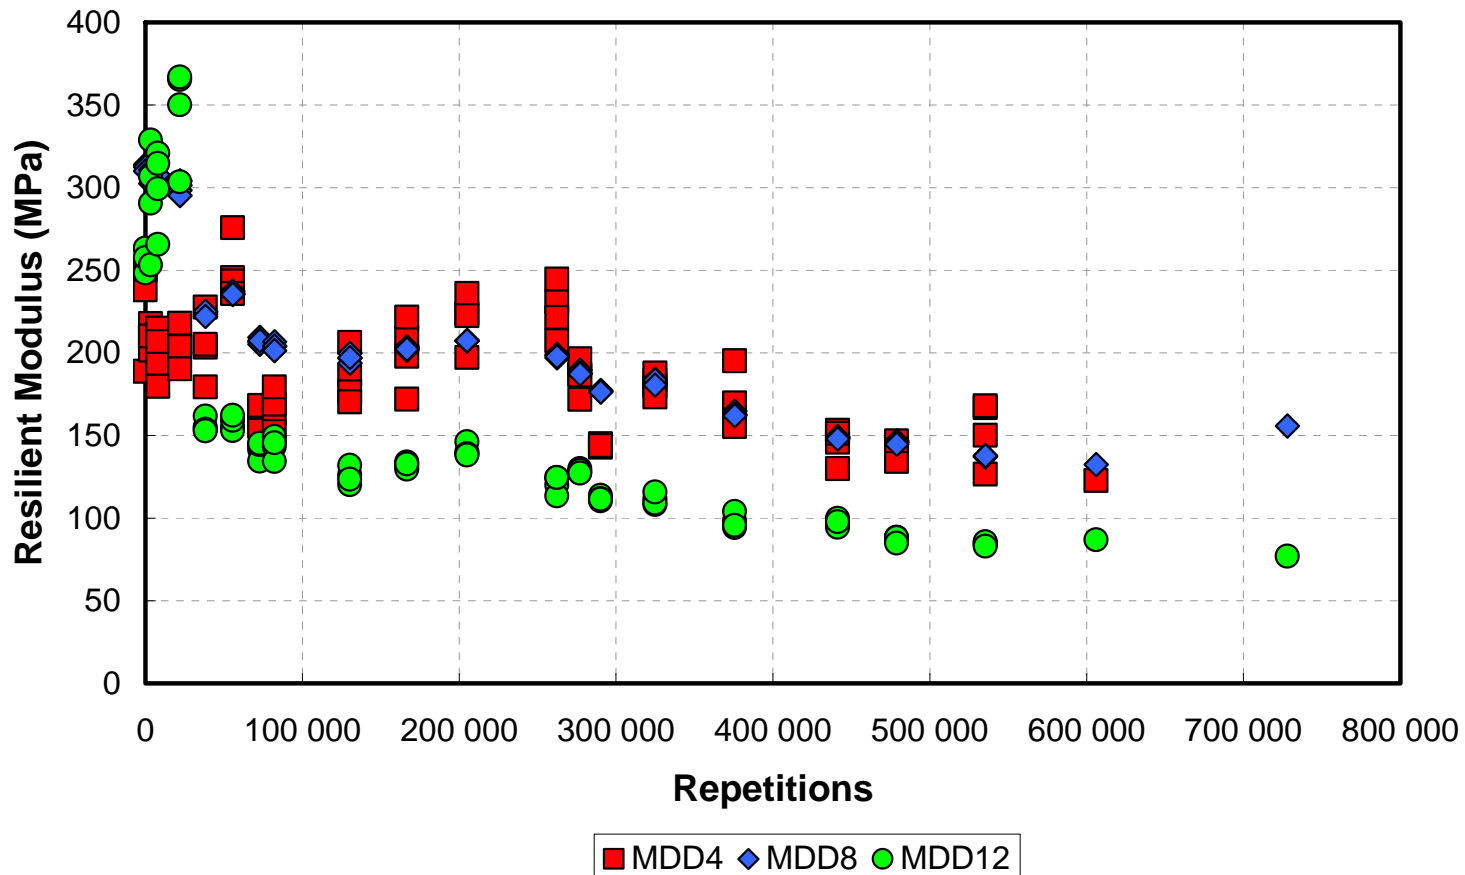
# Stiffness vs. HVS Repeats

Phase I: HVS test 425A5  
Upper subgrade resilient modulus at 40 kN

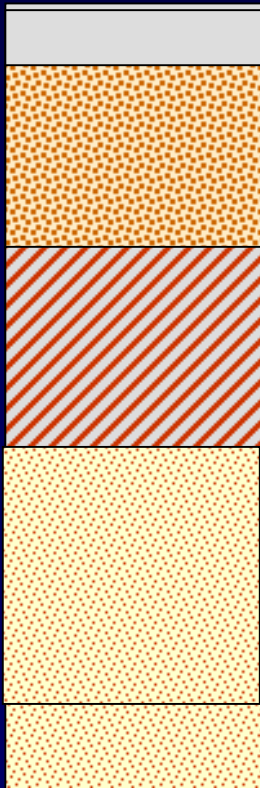
50 mm AC

150 mm G1

200 mm C4  
250 mm C4

150 mm G7
