HVSIA meeting 2009

European project SPENS

Sustainable Pavements for European New member States

HVS tests in Slovenia and Poland

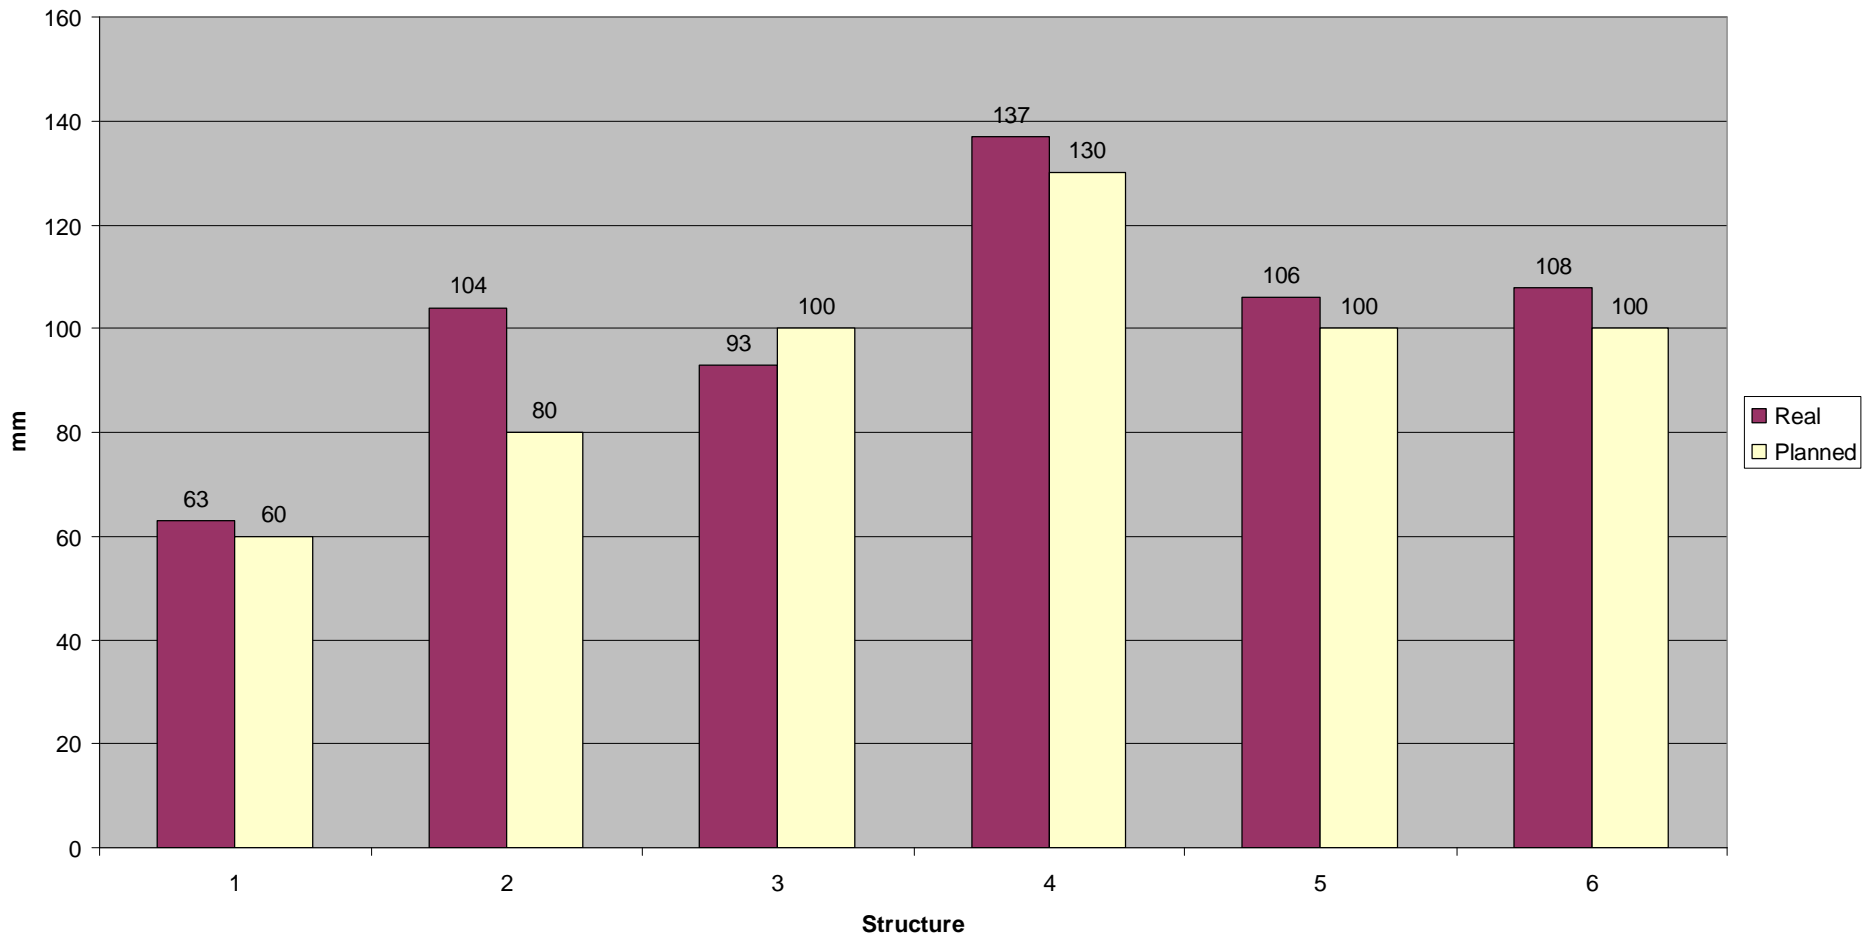
Planned & Actual AC thickness

AC thickness

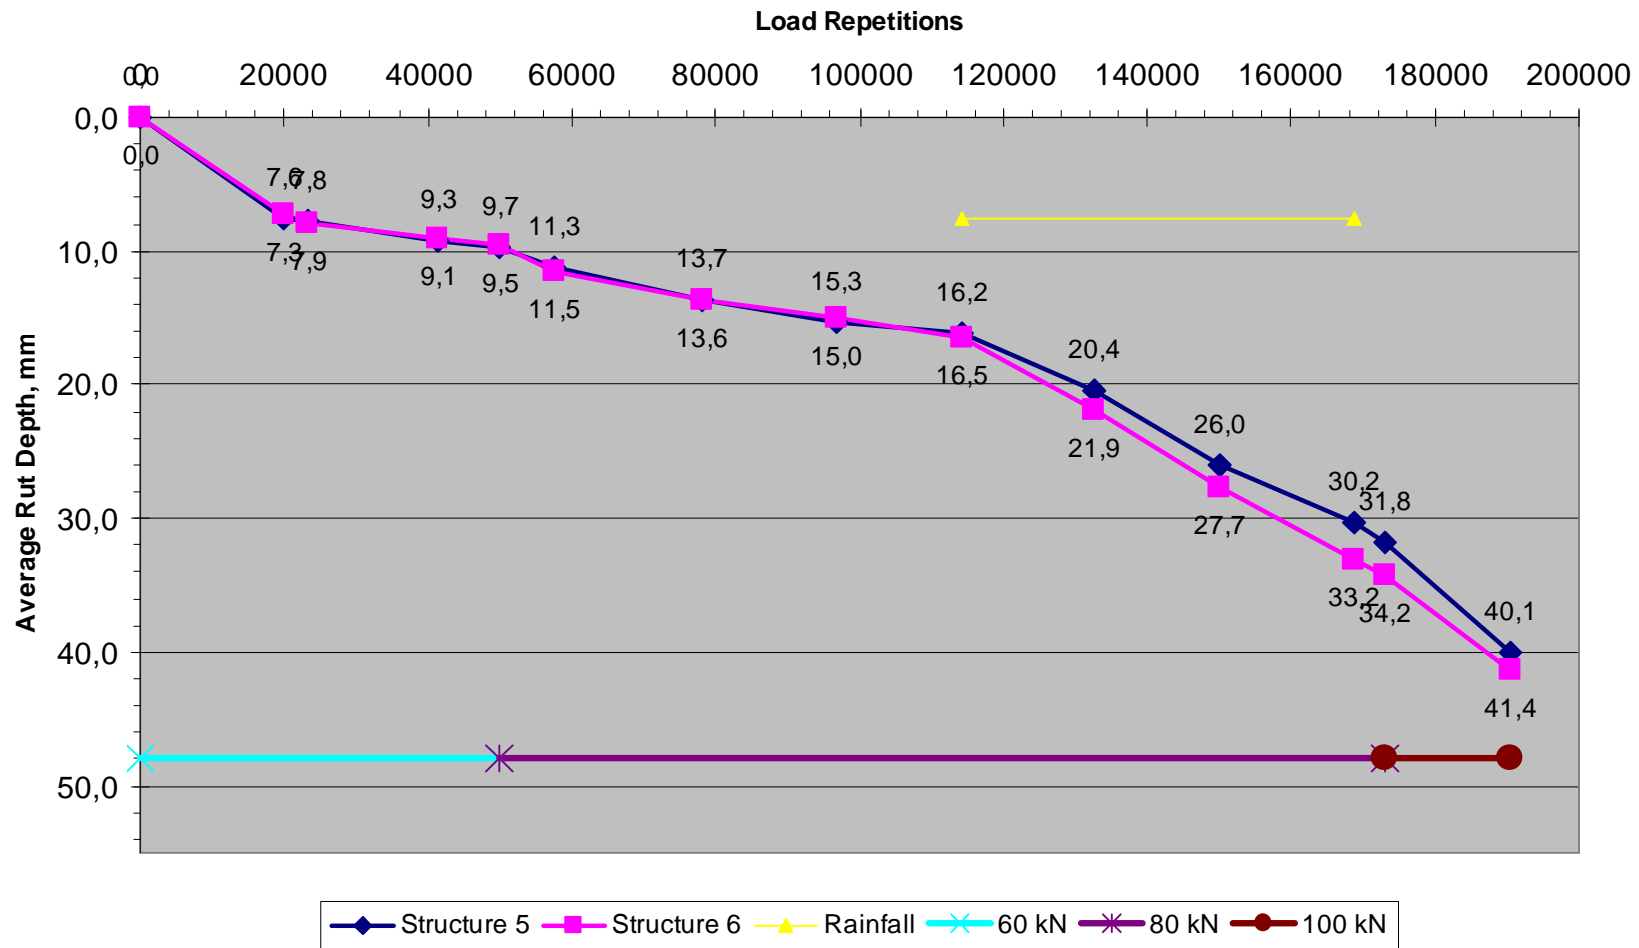
Influence of rainfall

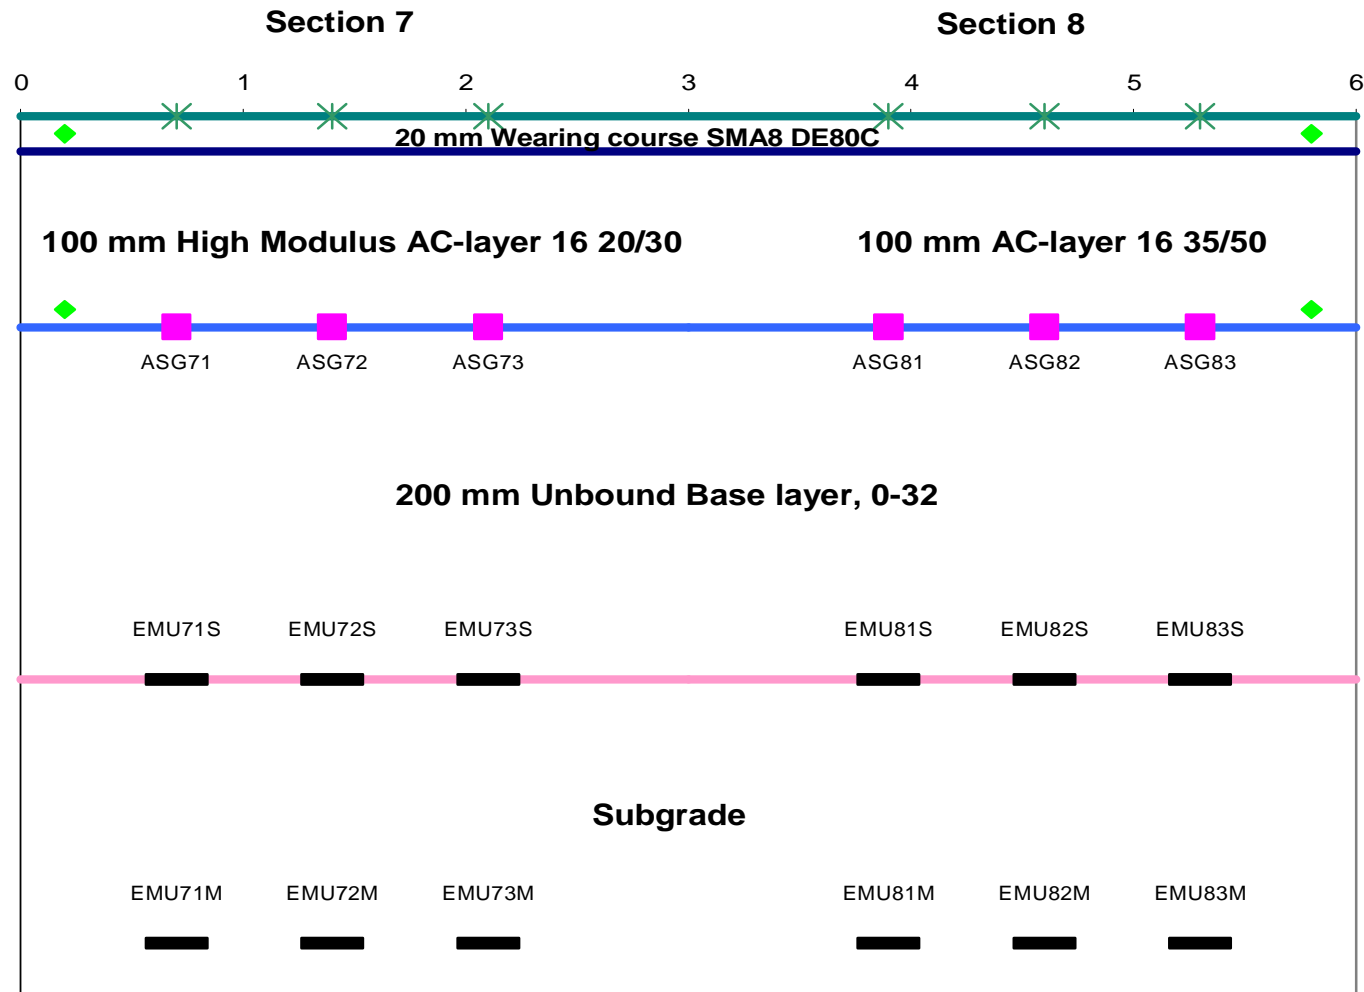
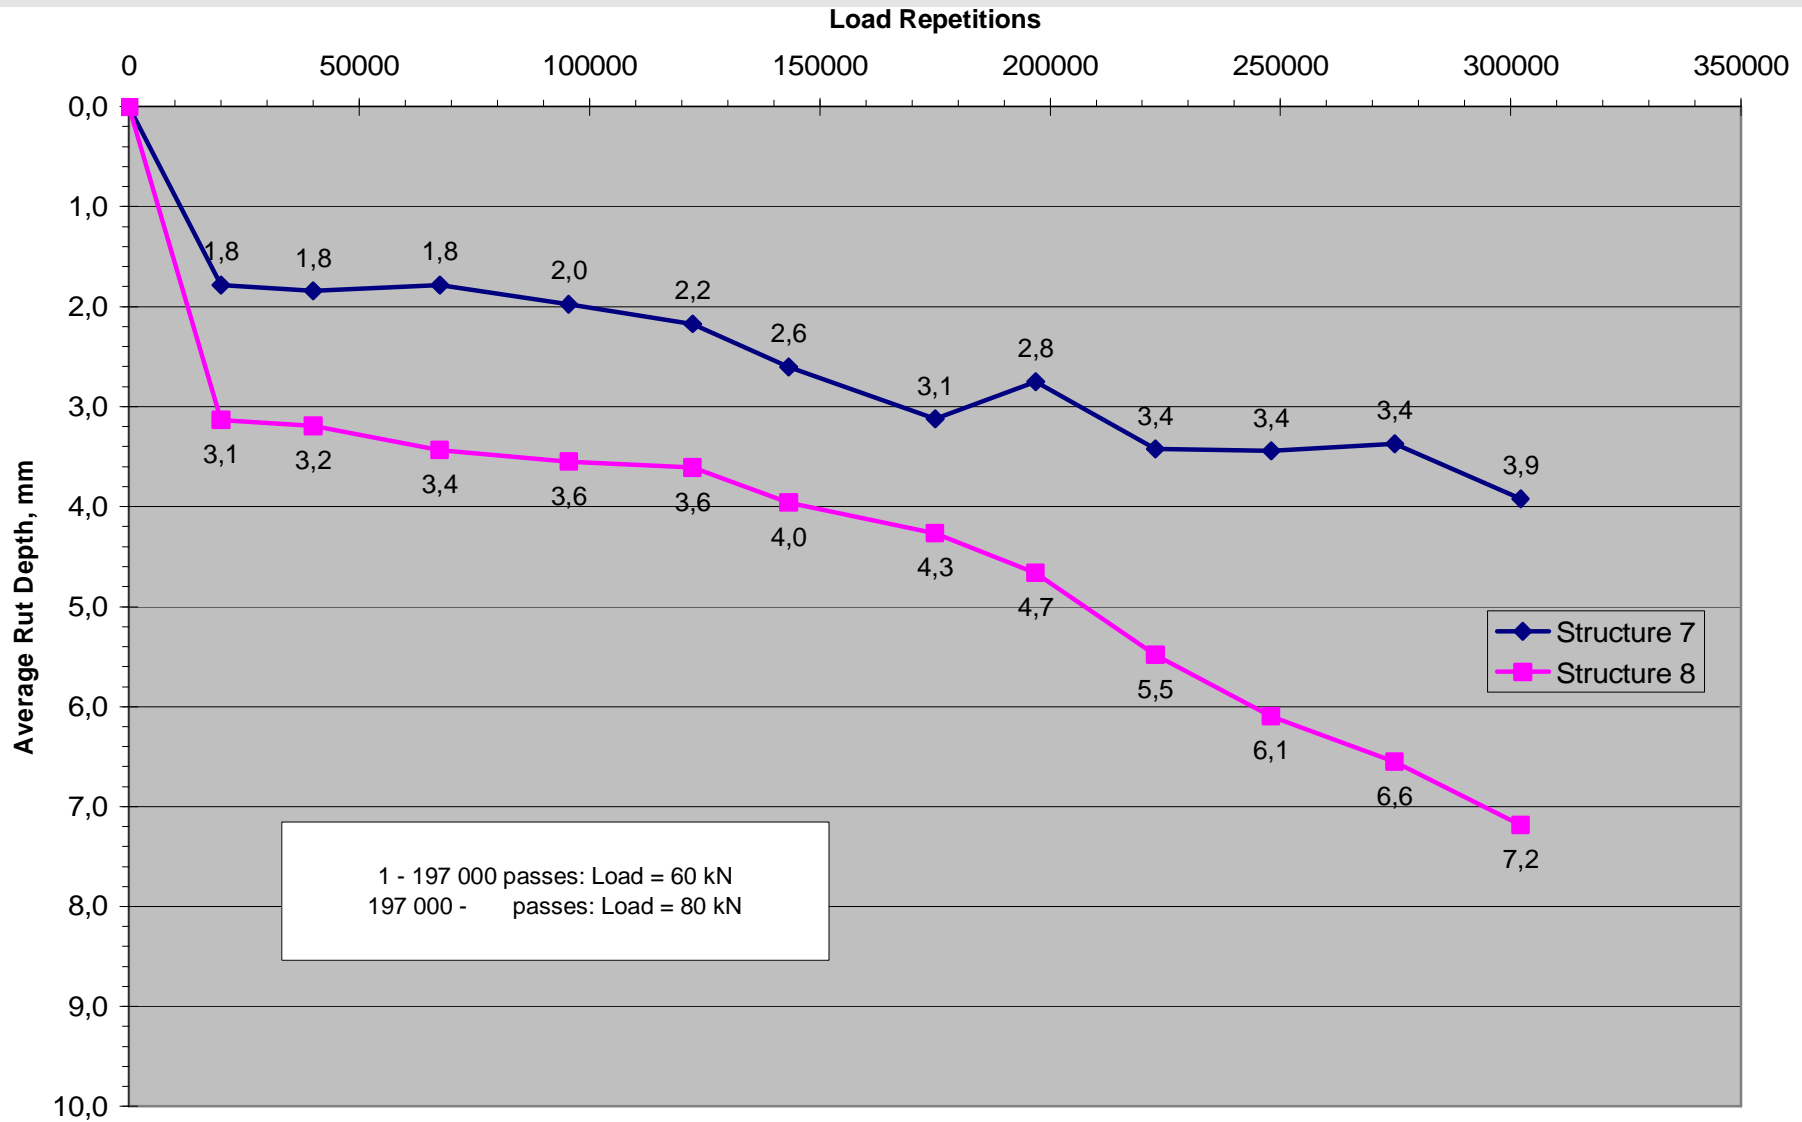
Test Field 1 in Poland

- Lateral AC strain
- Subgrade deformation
- ◆ Temp sensor
- ✱ Cross profile

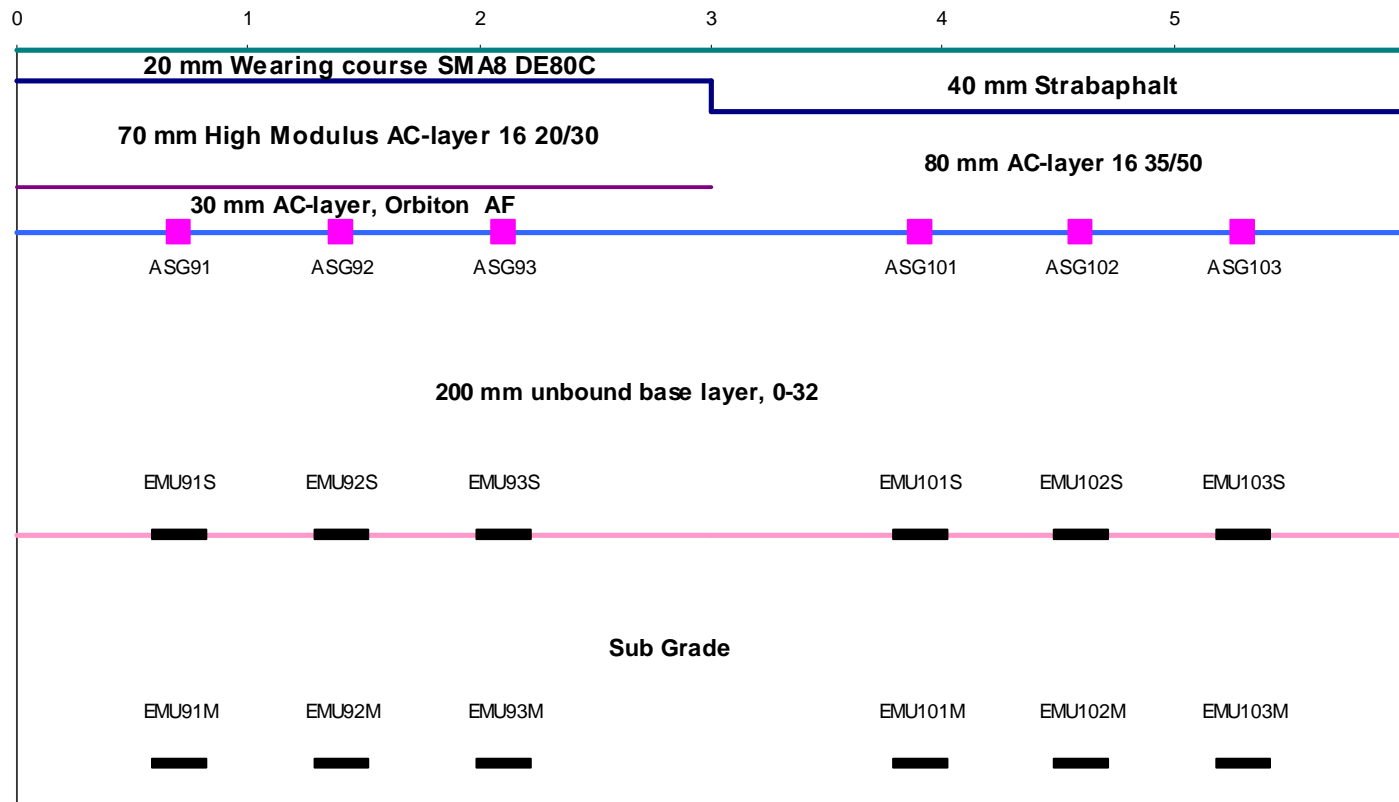
Test Field 2 in Poland

Test sections 9 and 10

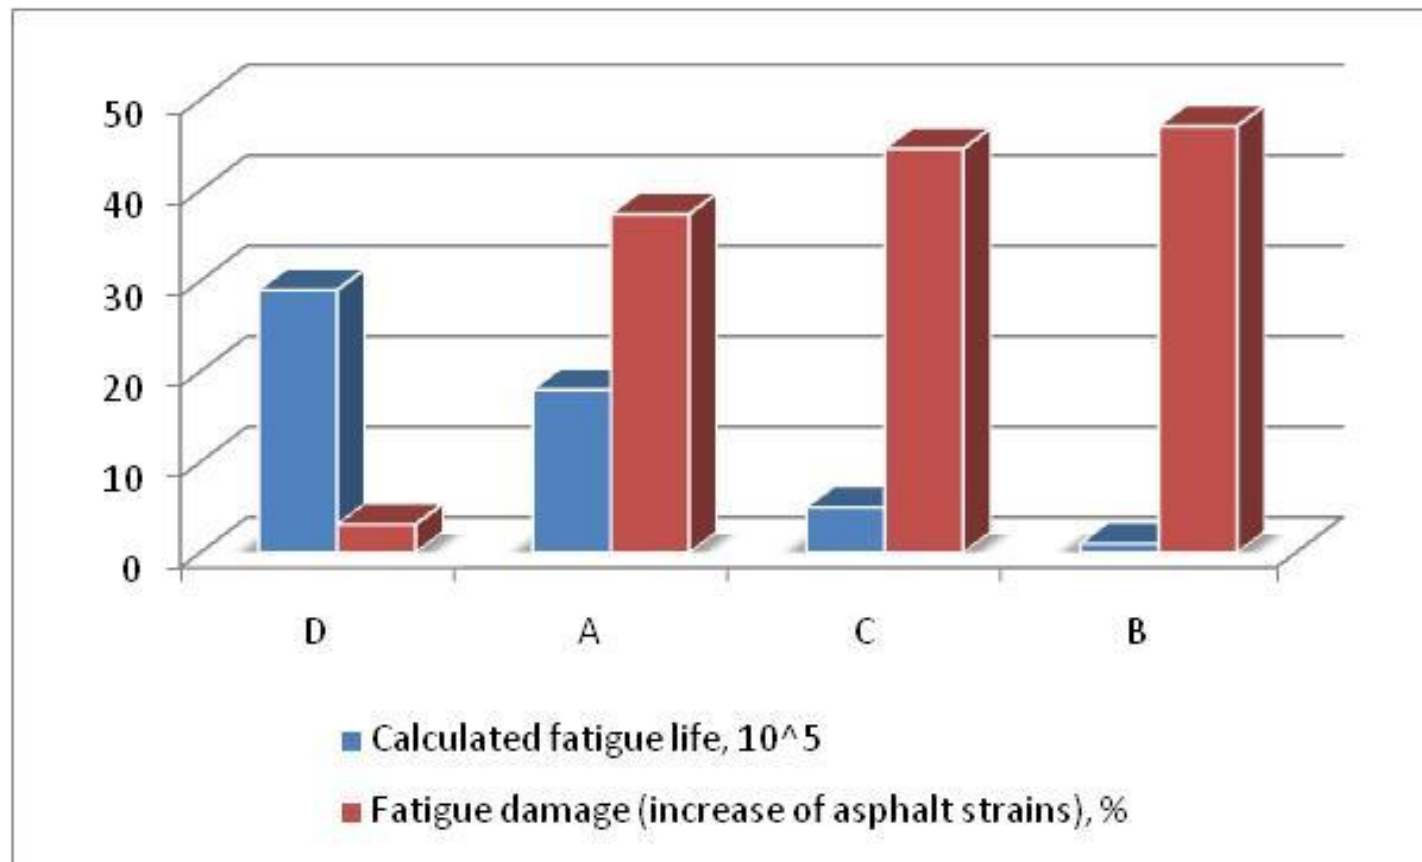
Calculated fatigue life vs Fatigue damage

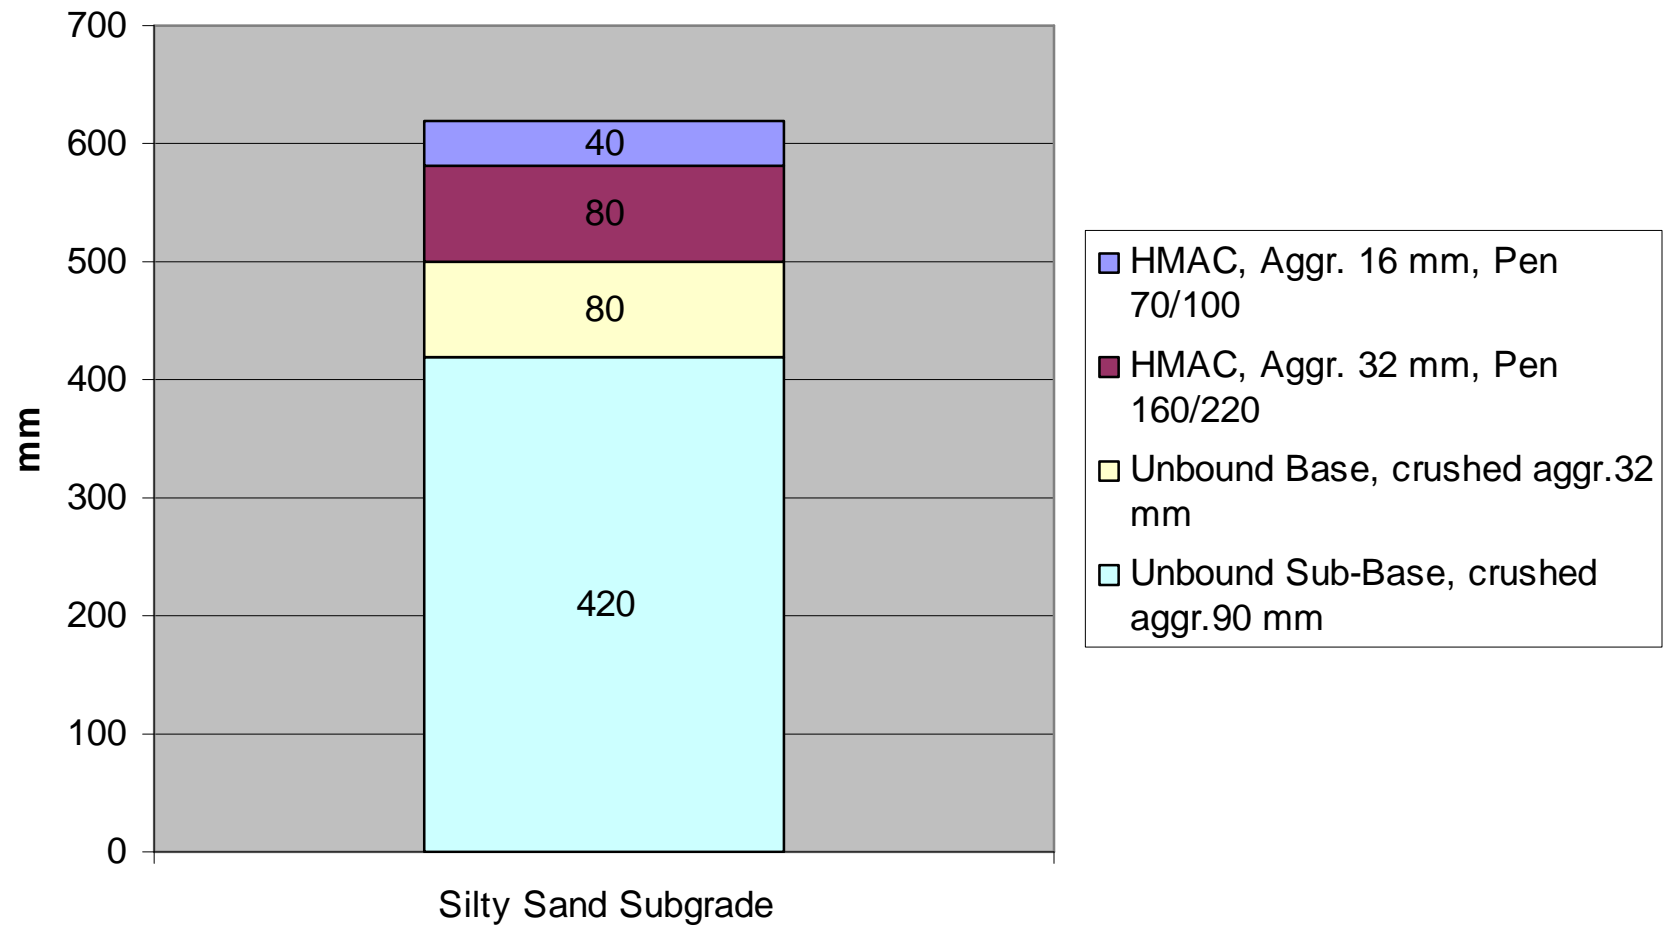
- » Repetition of the previous test in Sweden which was a reference test with a typical medium traffic volume structure according to the Swedish design guide

Test structure, Swedish reference

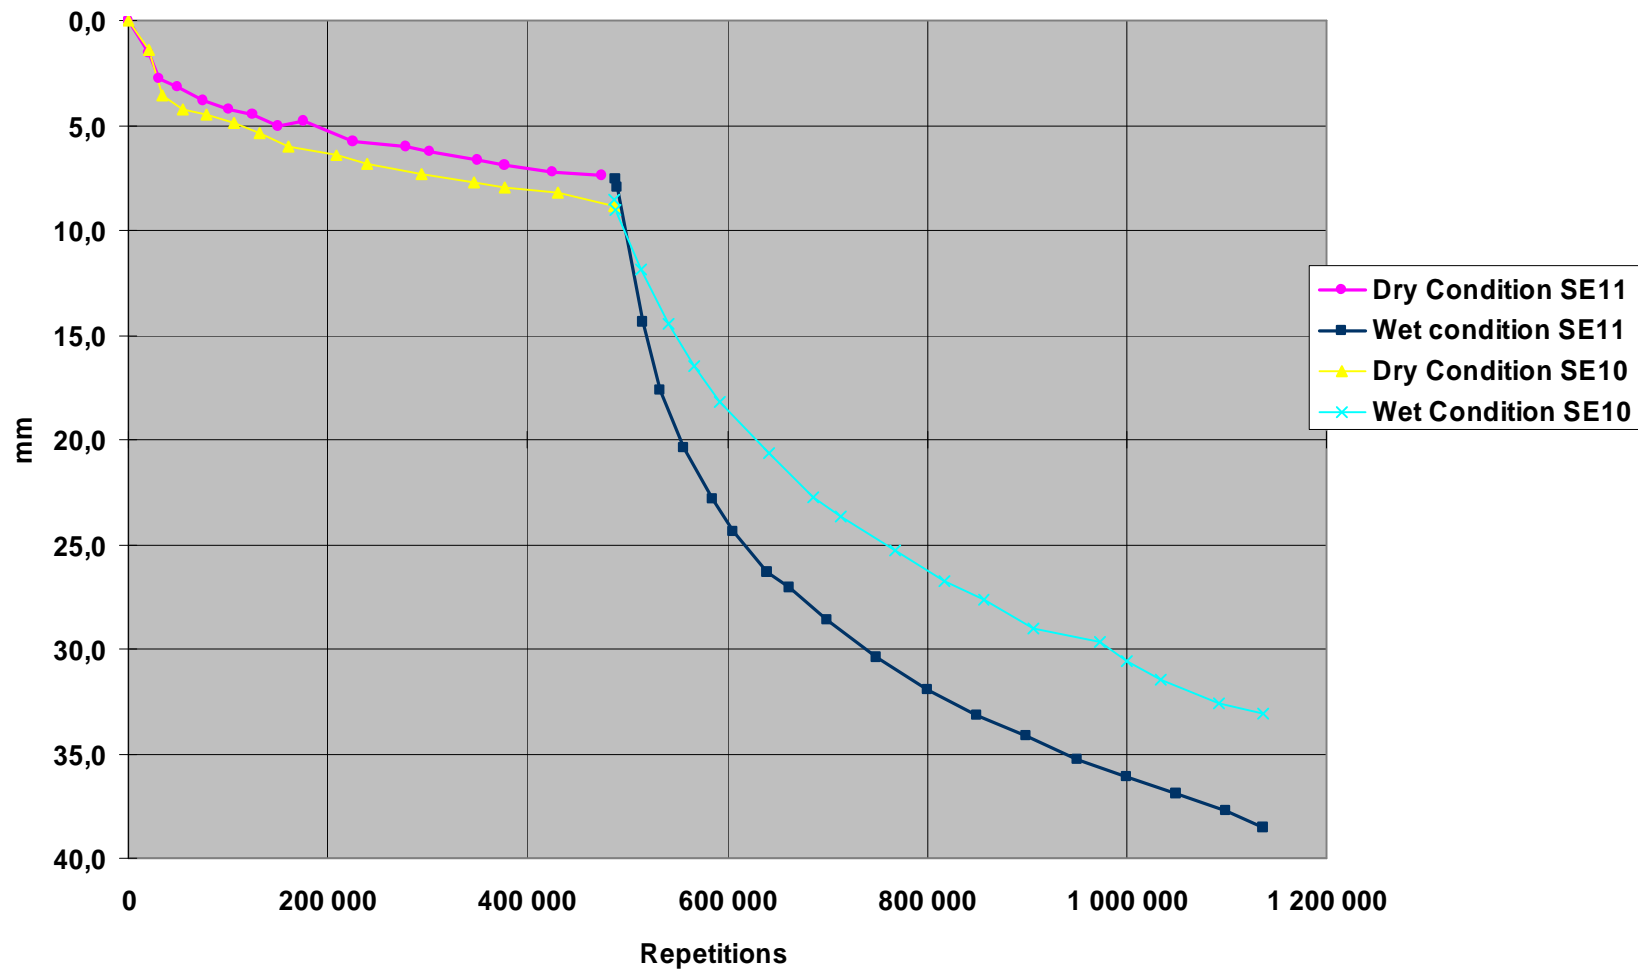
SE11 vs SE10

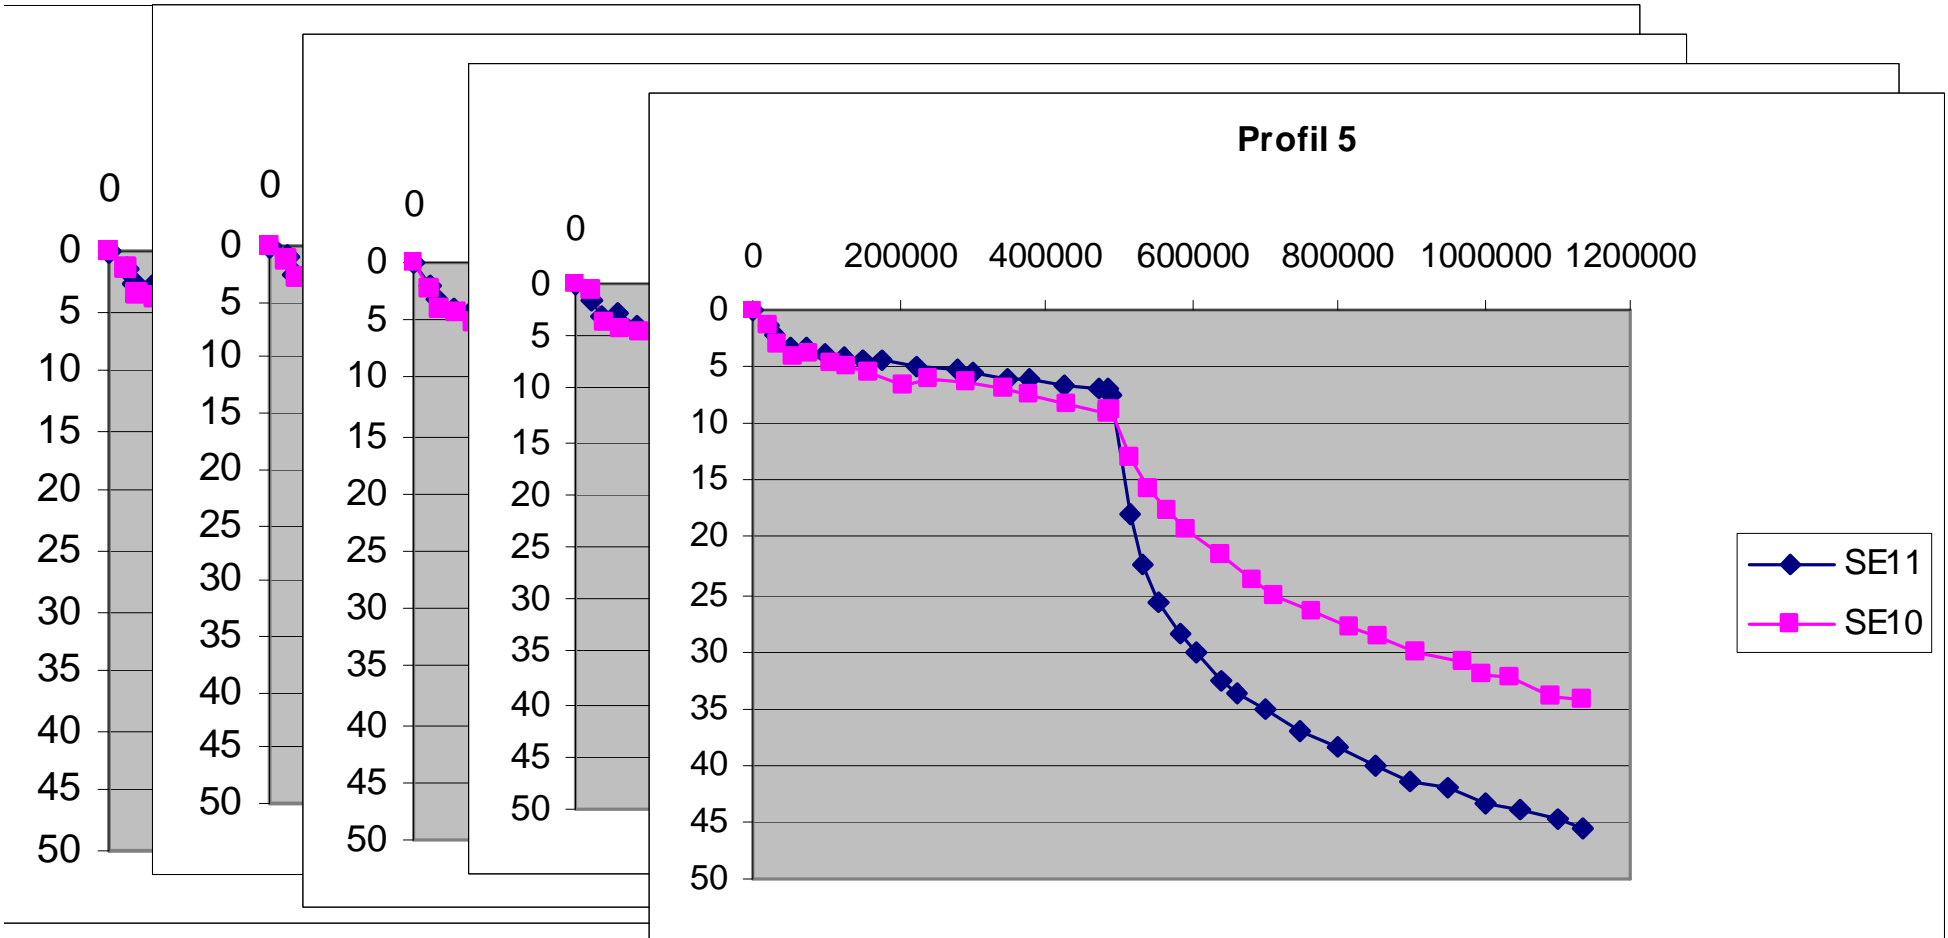
Longitudinal position 1 to 5
