# HVSIA HMA FEEDBACK

3 to 5 November 2009

# HVSIA HMA feedback

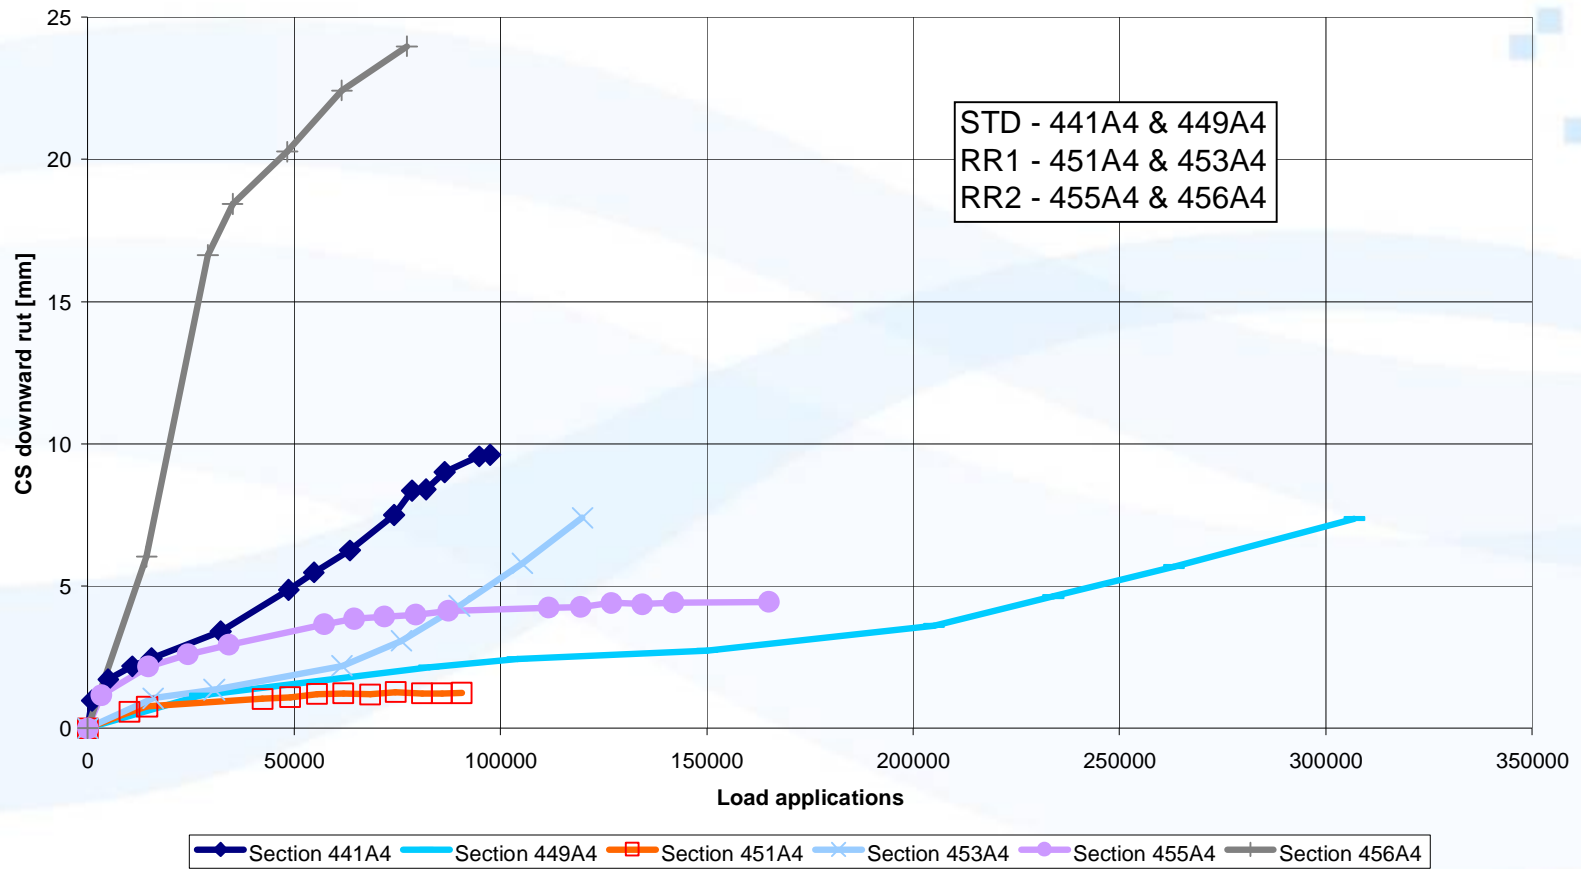
# Rutting graph

Comparison between RR1, RR2 and STD

- Rut development at higher temperature (RR1) similar to rut development at 60°C
  - Indicates possible aggregate interlock
- Rut development (under channelised conditions) for RR2 mix much less than for the STD mix, indicating that improved aggregate packing may lead to beneficial rut resistant mix (also refer to the loading conditions).

- expected permanent deformation lives of 3 mixes are 1:3,6:10 for the STD:RR2:RR1 HMA mixes

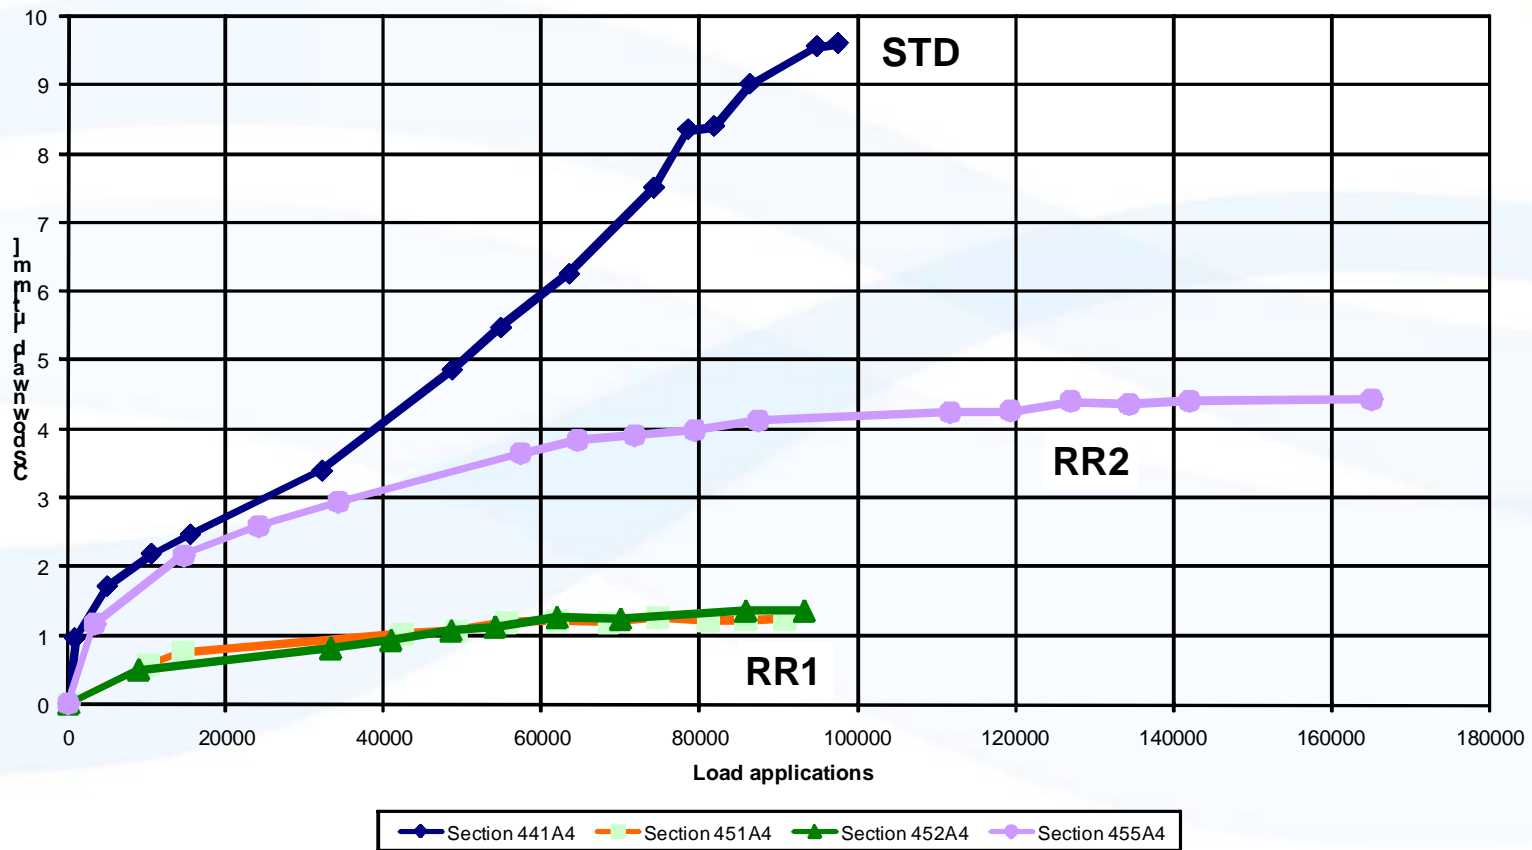
# Rutting graph

STD vs RR1 vs RR2

- 2 different loading conditions
  - standard (40 kN, 620 kPa) channelised uni-directional load
  - n-shaped (60 kN, 800 kPa) wandering bi-directional load
- caused higher load case to develop higher permanent deformation (as expected)
- Wandering, bi-directional, n-shaped load case caused higher permanent deformation in 2 RR mixes than in the STD HMA mix.
- Most reasonable explanation - age of binder at time of test
  - age of standard HMA test (449A4) to be more than 4 times that of 2 rut resistant HMA mixes when testing started
